January 31, 2018

City of Aztec  
610 Western Avenue  
Aztec, New Mexico 87410

RE: Raw Water Reservoir No. 1 Sediment Pond  
GEOMAT Project No. 171-2828

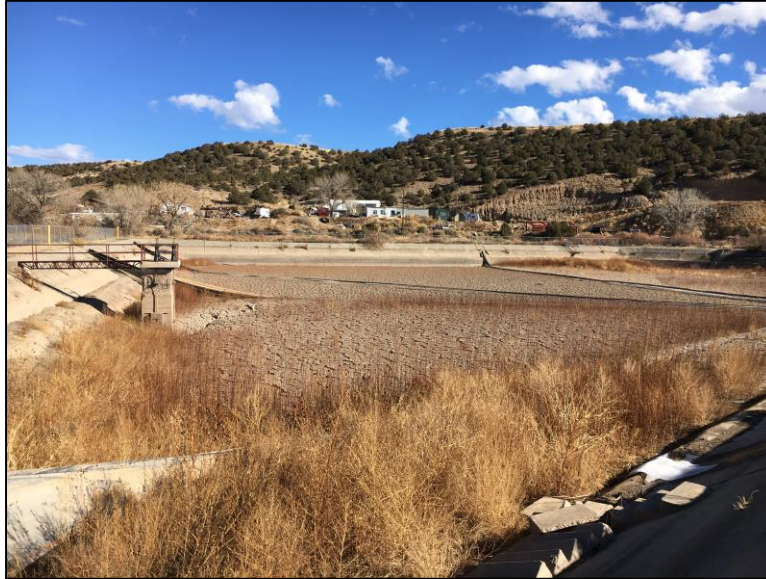
Conditions at the pond at the time of our field work are illustrated in the following photographs. Figure 1 shows the view looking east from the top of the embankment at the northwest corner of the pond. The pond inlet is located to the bottom left outside the photograph, the intake tower is to the center left, and several of the fabric baffles separating the pond into five different cells can be seen across the pond. The slope of the concrete sides is constant around the pond, but the depth from the top of the embankment to the top of the sediment varies across the pond. As depicted in Figure 2, the surface of the pond bottom was dry and cracked and no standing water was visible. The depth and width of the surface cracks varied across the pond, but ranged from approximately 1-inch to 10-inches wide and 2-inches to 3-feet deep, resulting in soil pieces that were on the order of 10-inches wide by 18-inches long. The degree of cracking was less pronounced around the perimeter of the pond and became more prominent towards the center. The photograph in Figure 2 was taken adjacent to Boring No. B-2.

Figure 1 – View looking east from the top of the embankment from the northwest corner of the pond.

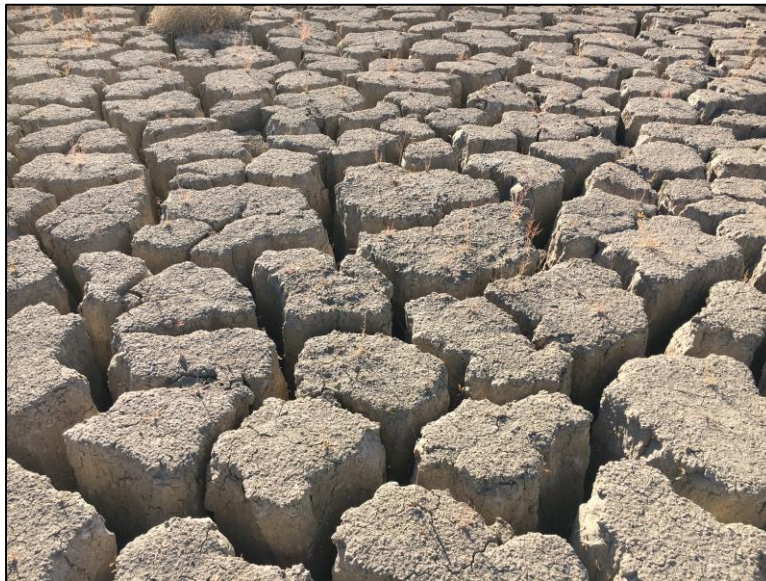
Figure 2 – Cracking in the surface of the pond adjacent to Boring No. B-2.

Three different conditions were encountered in each of the borings. The soils at the ground surface to depths of approximately 2 to 3 feet were relatively firm, dry, and structured in blocky, creviced islands as depicted in Figure 2. The soils encountered at depths ranging from 2 to 3 feet and extending from 4 to 7 feet were soft to very soft. The soils at these depths were moist to

- The upper portions of the soils in the pond, although creviced, appear suitable to support light construction equipment.
- The type of equipment that will be suitable for use will have to be determined based on field trials. However, lightweight rubber-tracked equipment may be required.

- The sediment could be removed with a lightweight rubber-tracked excavator and small dump trucks by excavating the sediment to the full depth operating on the dry surface soils and working systematically across the such as to always operate on the dry surface soils.

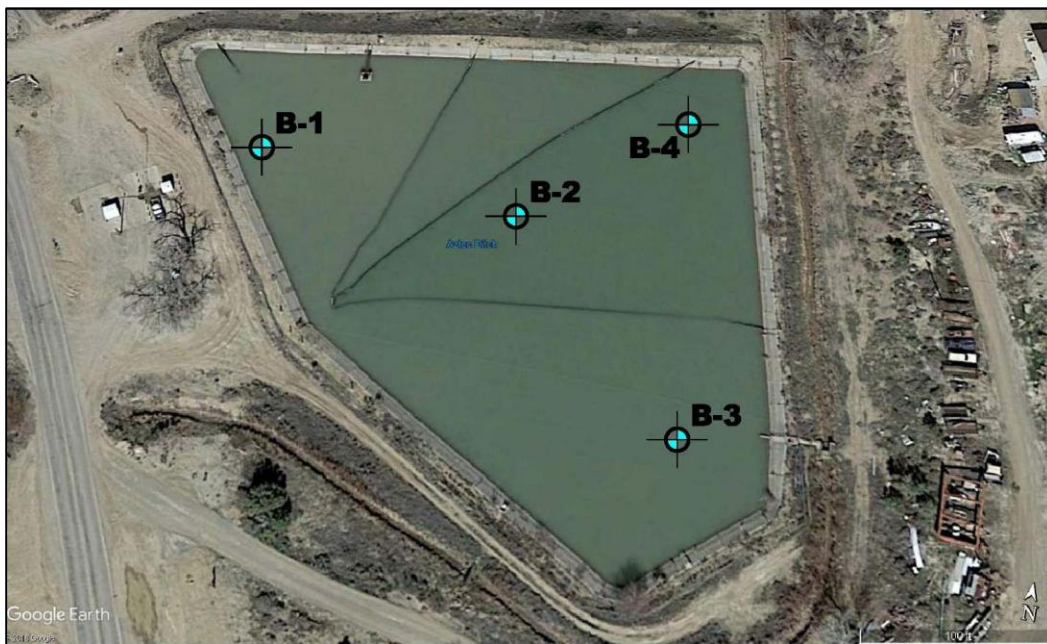
GEOMAT performed drilling and sampling of four hand-auger borings to the depths where the clay liner material appeared to be encountered. Select samples obtained from our field borings were returned to our laboratory and tested to determine the moisture content. Conditions encountered in the test borings and the approximate boring locations within the pond are presented in Table 1 and Figure 3, respectively.

Figure 3 – Test borings approximate locations within Reservoir No. 1.
