MEMORANDUM

DATE: October 14, 2019

SUBJECT: City of Aztec Reservoir No. 1 Rehabilitation Project

The City of Aztec has contracted Bohannon Huston, Inc. (BHI) to evaluate the existing condition of Reservoir 1 in Aztec, NM, as well as assess the rehabilitation potential of the reservoir and make a recommendation on whether the reservoir should be rehabilitated or if it is more advantageous to construct a new reservoir.

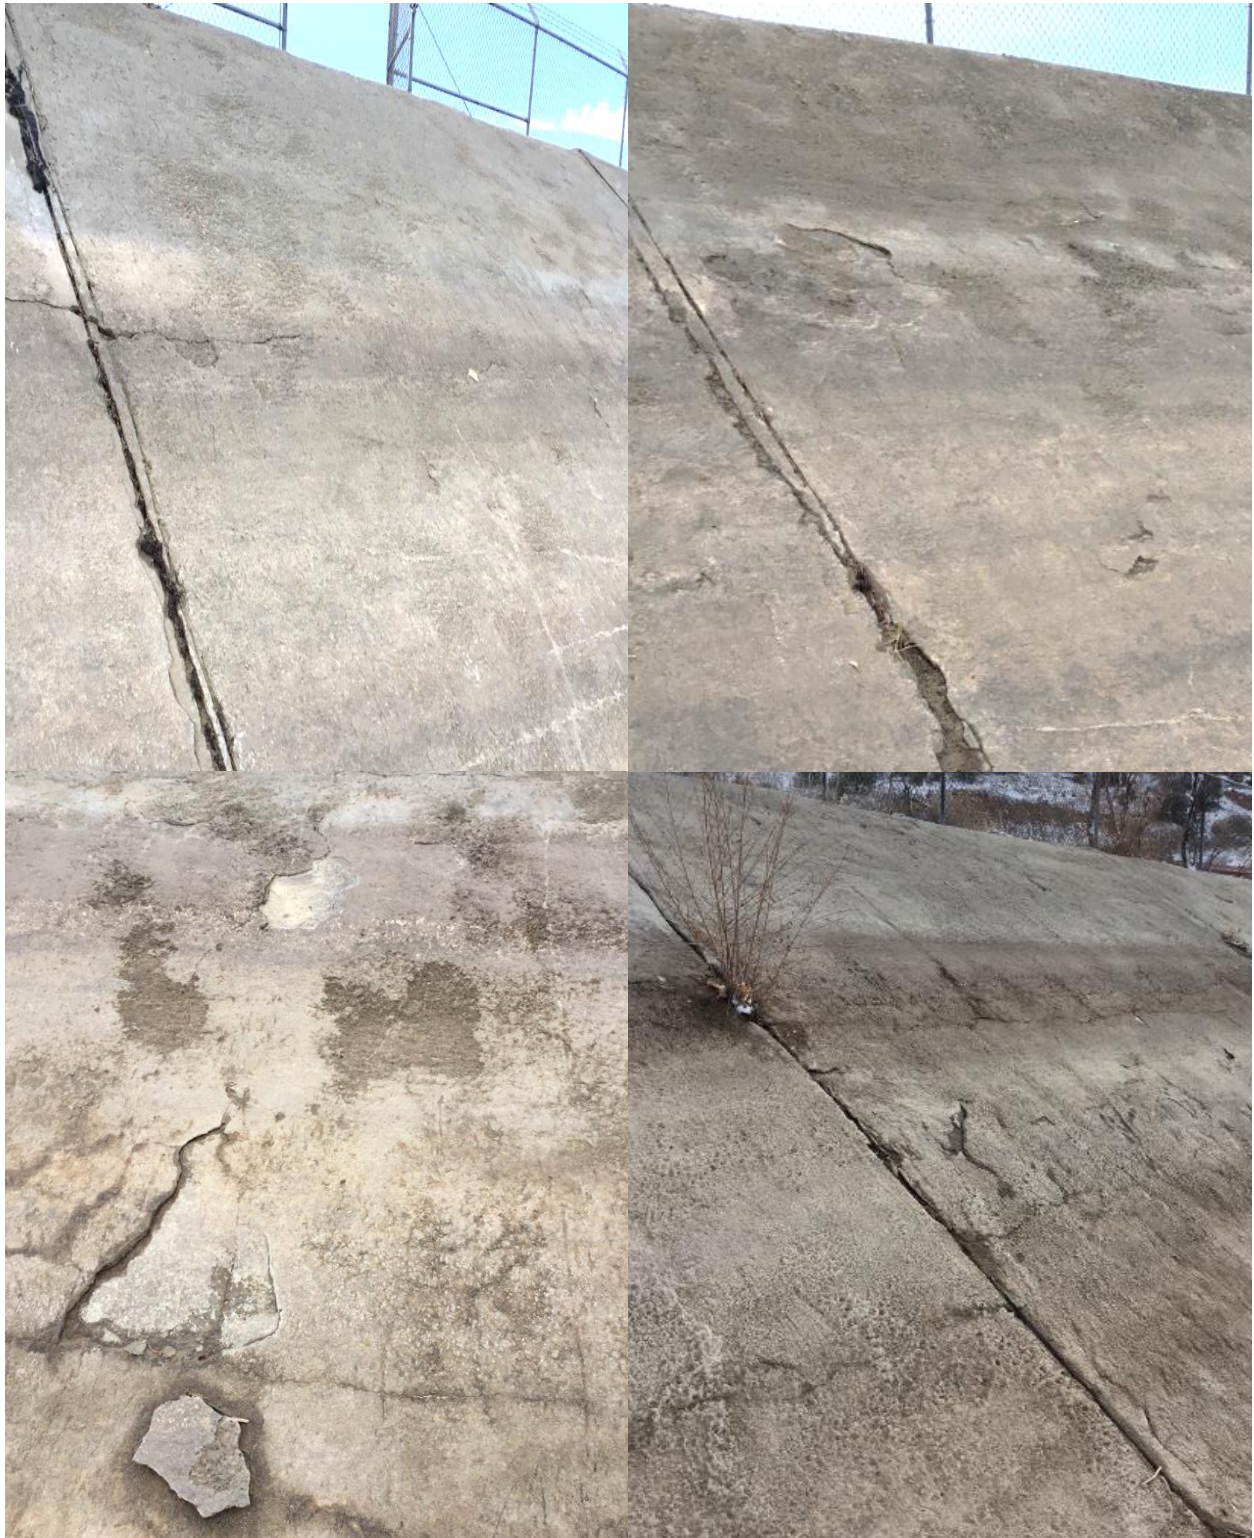
Figure 2 – Rating 4 Example

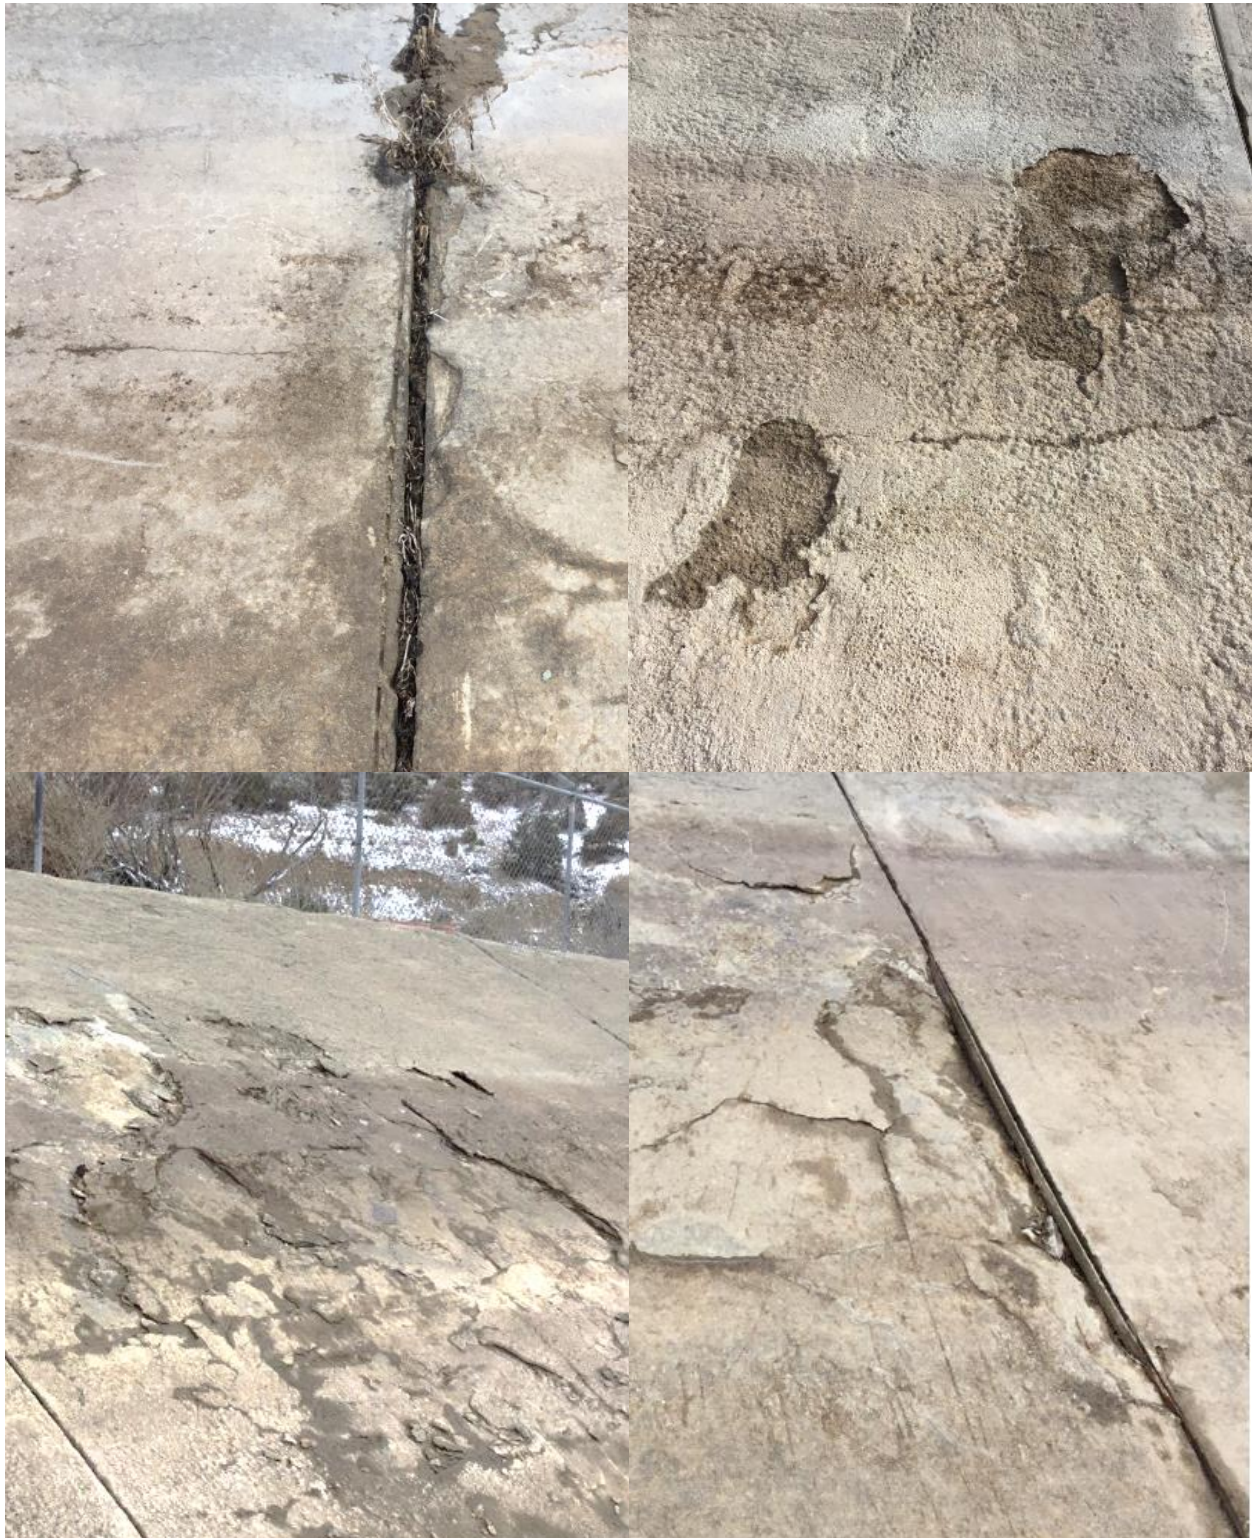
Figure 3 – Rating 3 Example

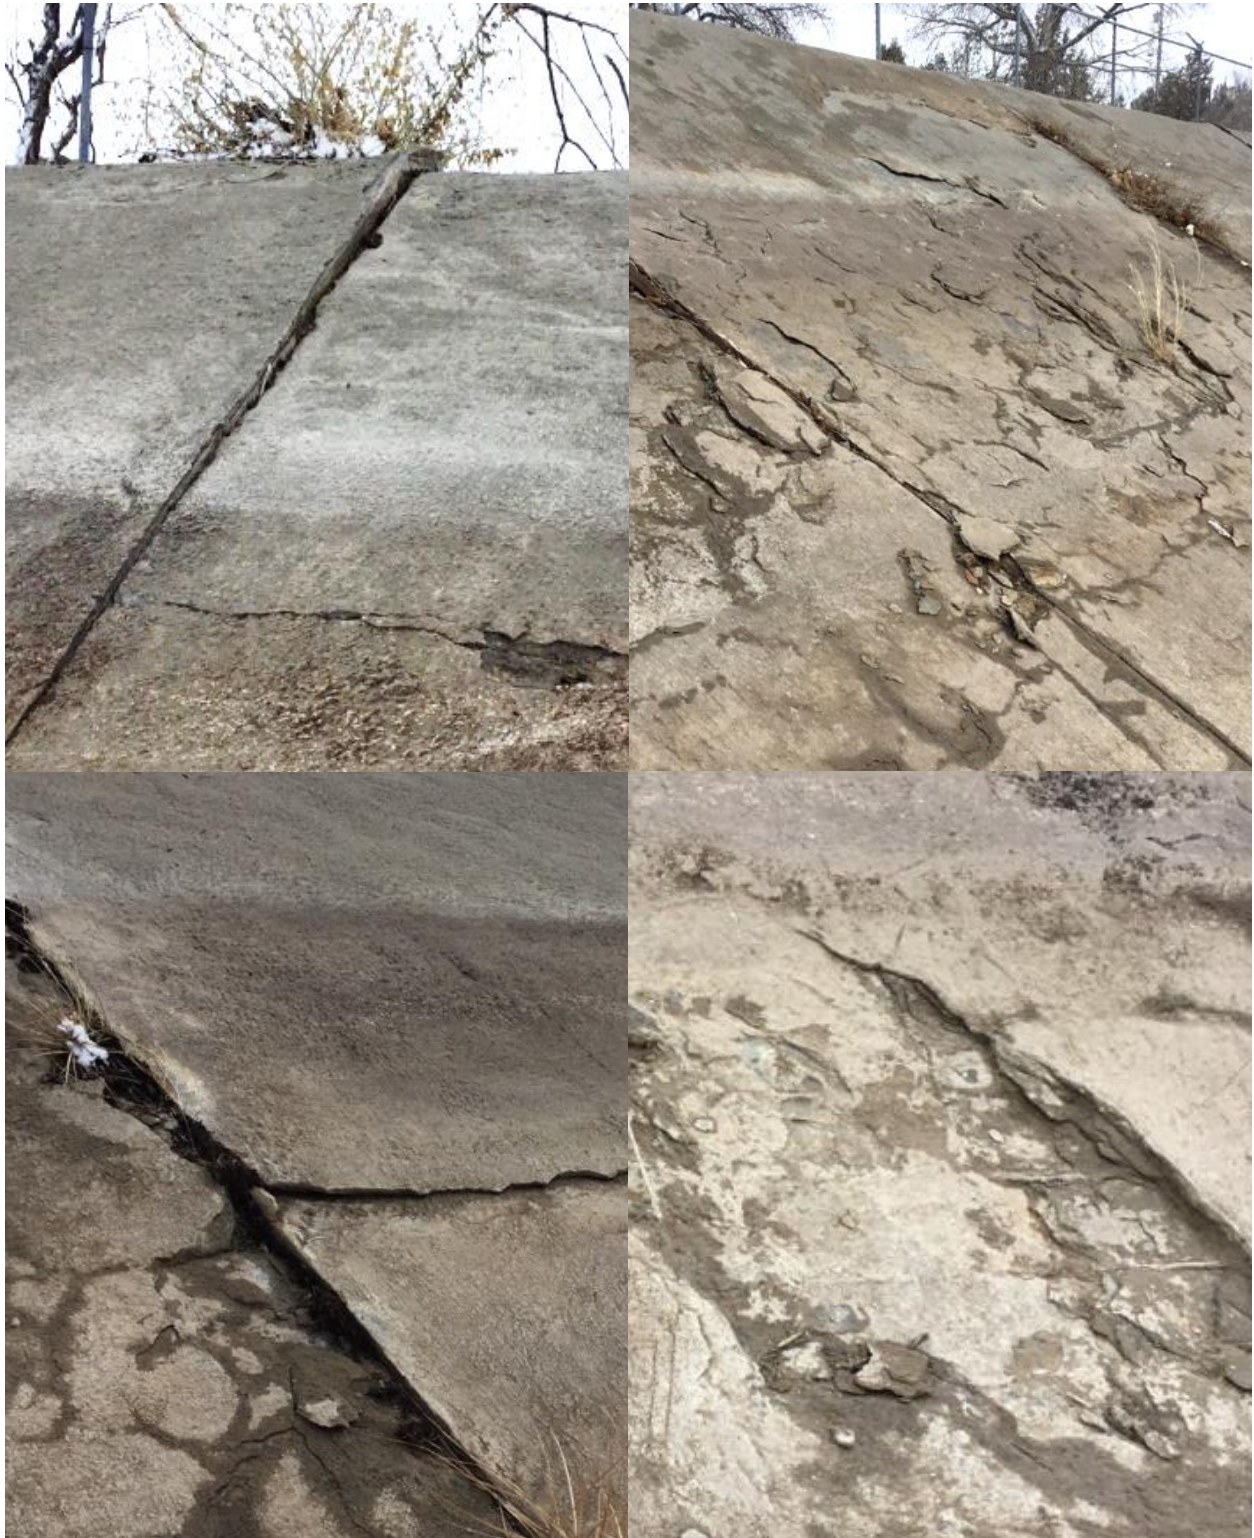
Figure 4 – Rating 2 Example

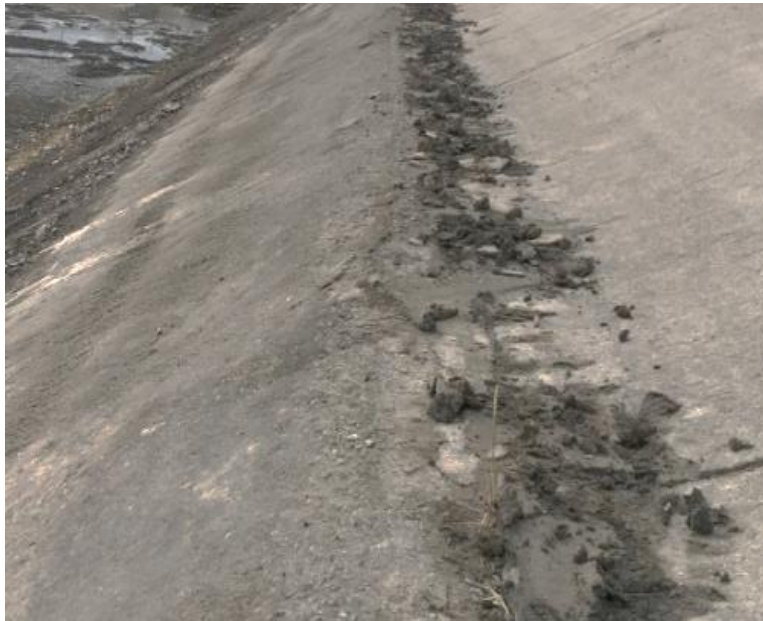
Figure 7 – Signs of Spalling

In general, Zone 1 presented signs of spalling covering approximately 4 ft below the horizontal ledge (See Figure 7). Zone 2 presented longitudinal cracks of 1/8 inch up to 1/4 inch (see Figure 8 and Figure 9) and had significant signs of delamination and spalling (see Figure 10 and Figure 11).

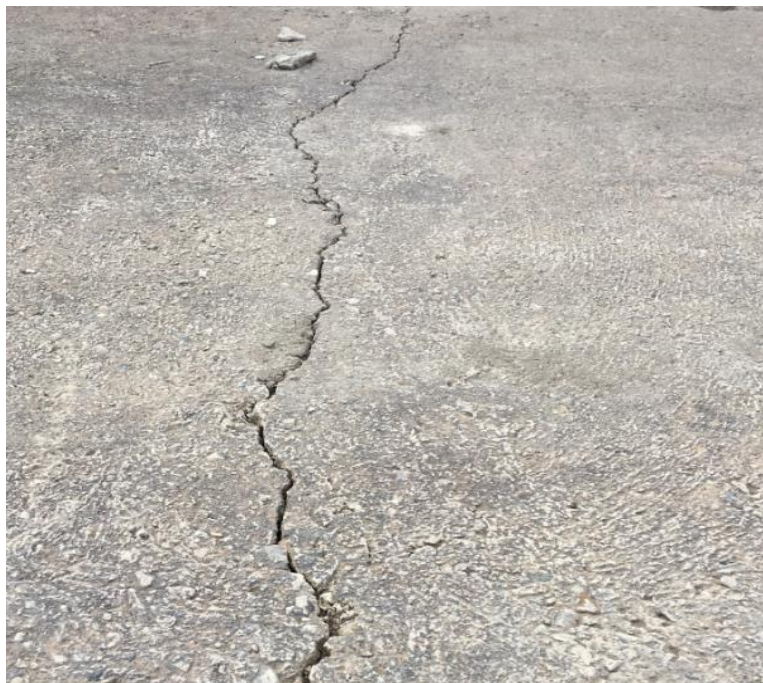
Figure 8 – Longitudinal Crack

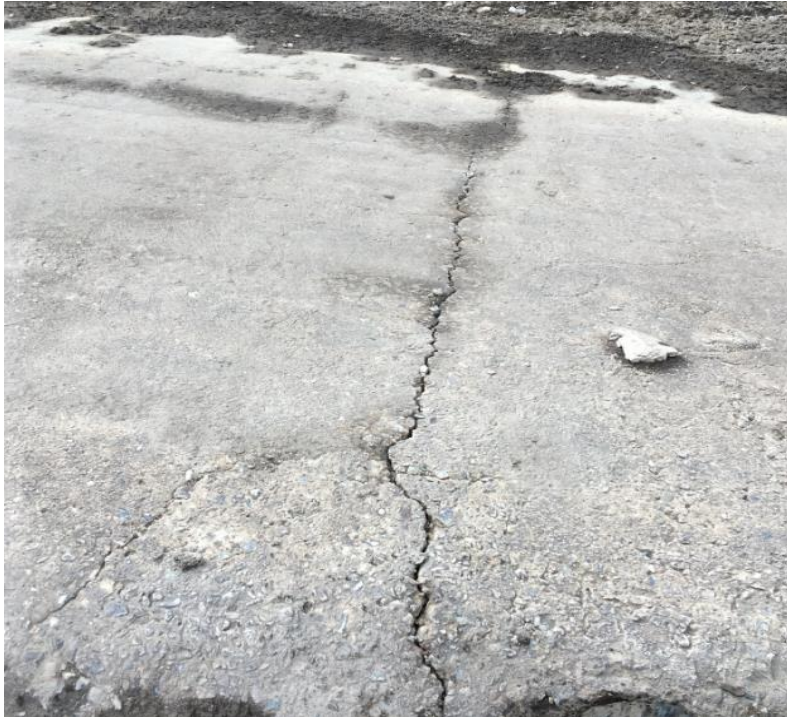
Figure 9 – Longitudinal Crack

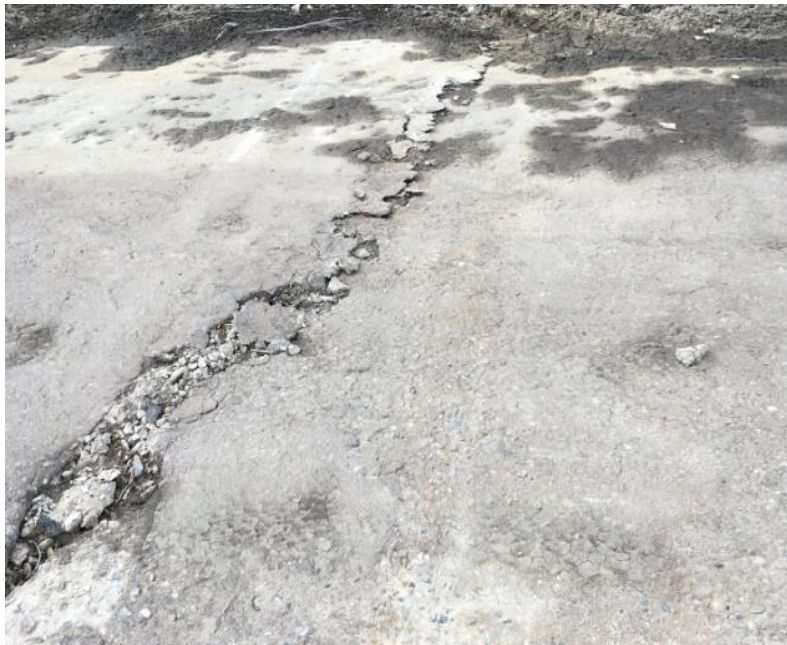
Figure 10 – Longitudinal Crack with Delamination

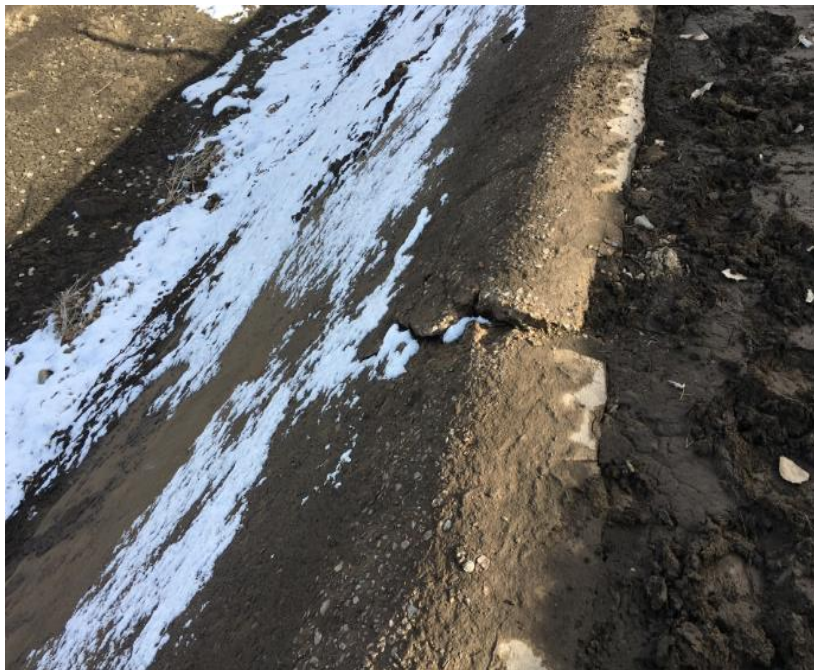
Figure 14 – Longitudinal Crack

Zones 3, 4, and 5 presented similar conditions throughout. Most of the upper portion of the layer is undergoing spalling surrounded with longitudinal cracks in some locations (see Figure 12, Figure 13, and Figure 14). Major embankment failure surrounding the inlet pipe that transports water from Reservoir 2 to Reservoir 1 suggests underground water seepage is causing the bottom layer on Zone 4 to bulge out (see Figure 15 and Figure 16).

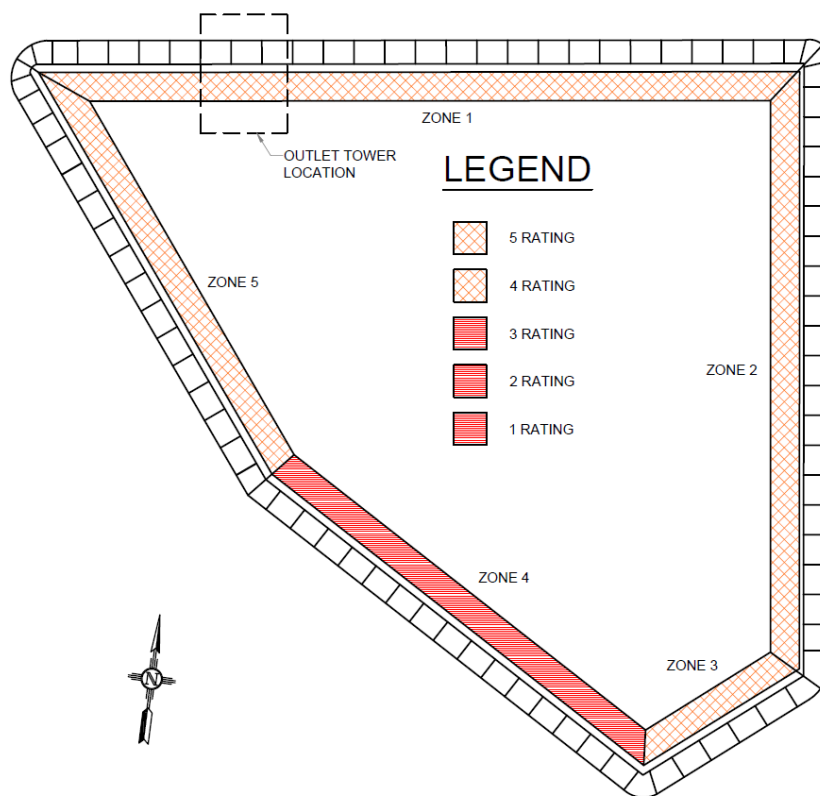
Figure 17 – Bottom 3” concrete lining (1954)

In general, zones receiving a rating of 3 or lower (shown in red in Figure 17) are considered to be in poor to bad condition. Zones 1, 2, 3, and 5 received ratings of 4 or higher (see orange hatch in Figure 17) in the visual inspection and are considered to be in fair condition.

Based on the field evaluation of the existing conditions of Reservoir 1, 71 percent of the upper 3-inch Gunite concrete lining (built in 1981) and 20 percent of the lower 3-inch concrete lining (built in 1954) is currently in poor to bad condition. This is due to joint failure, settlement, longitudinal cracking, delamination, and spalling conditions making Reservoir 1 not optimal for water storage. It is also necessary to understand where the current leakage is originating, the magnitude of water intrusion from Reservoir 2, and how settlement is affecting the embankment on Zone 4 to prevent future failure at this location.

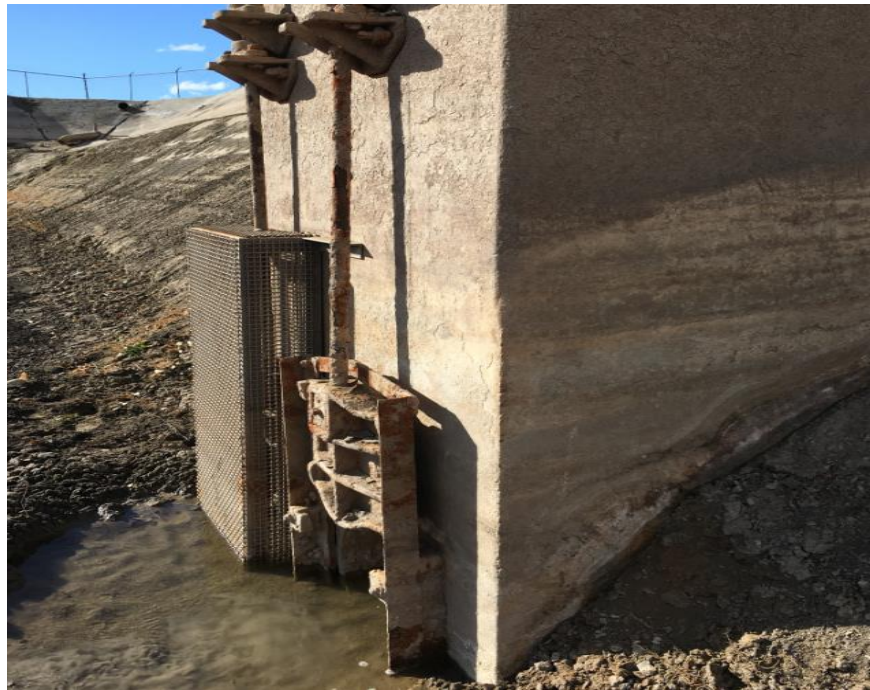
show instances of leaching at the lower and middle layers of the tower. Above these layers, the concrete tower was rehabilitated with the 2018 project (see Figure 21) and appears to be in good condition with some minor spalling on the underside of the platform. Nominal cracking due to temperature and shrinkage forces in the concrete are present (see Figure 22). Inside the tower, the concrete showed signs of spalling, causing loss of surface material (see Figure 23).

Figure 19 – Leaching at lower right corner of figure

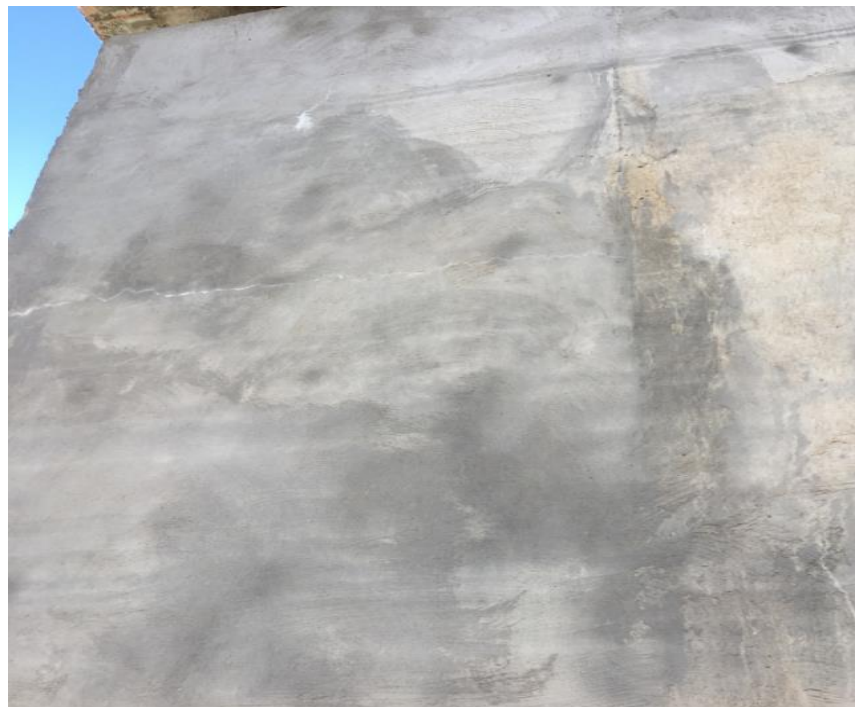
Figure 20 – Leaching in the Middle Cap of the Outlet Tower

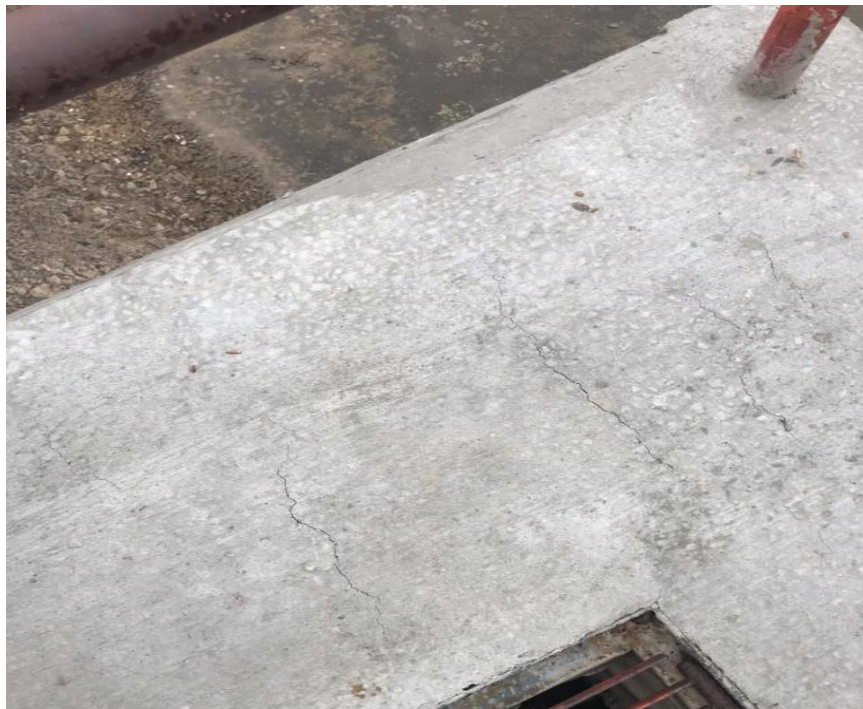
Figure 22 – Nominal Cracking
