**GEOTECHNICAL ENGINEERING REPORT
WILLIAMS ARROYO GABION WALL REPAIR
AZTEC, NEW MEXICO**

GEOMAT Project 232-4570

Based upon the information provided, we understand the existing wall is approximately 6 feet high with a length of 600 linear feet. A portion of the wall has been damaged and requires repair. Based upon information received from the design team, we anticipate that the work will consist of the removal and reconstruction of the damaged sections with new gabion walls and geofabric.

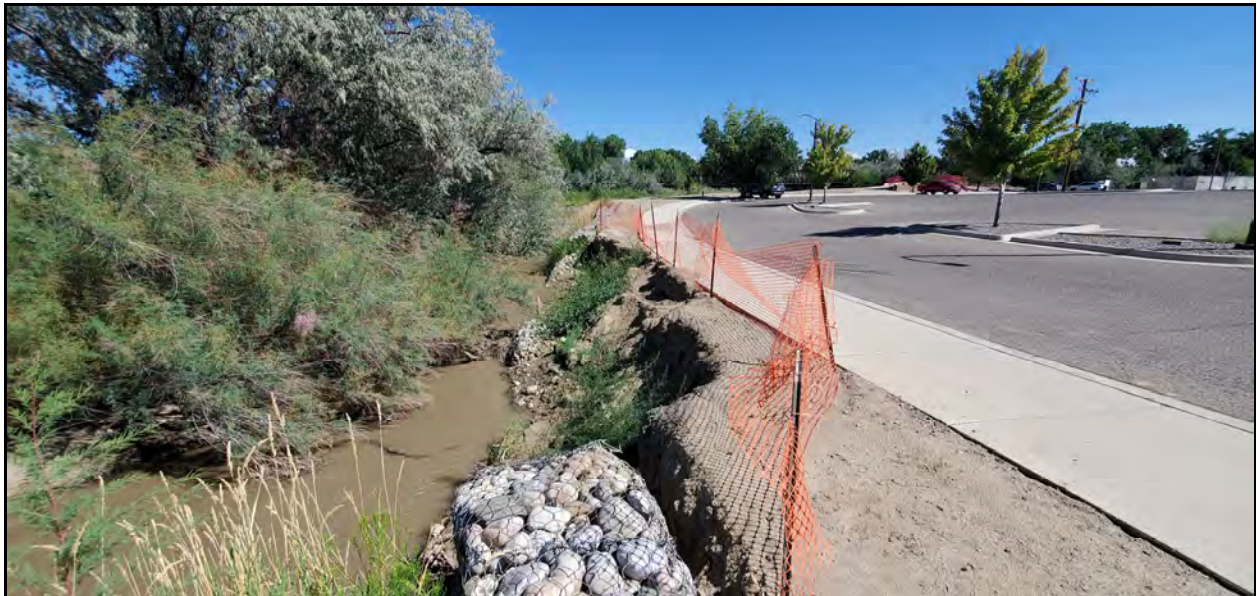
**Damaged Gabion Wall near Boring B-3
View Towards the North**

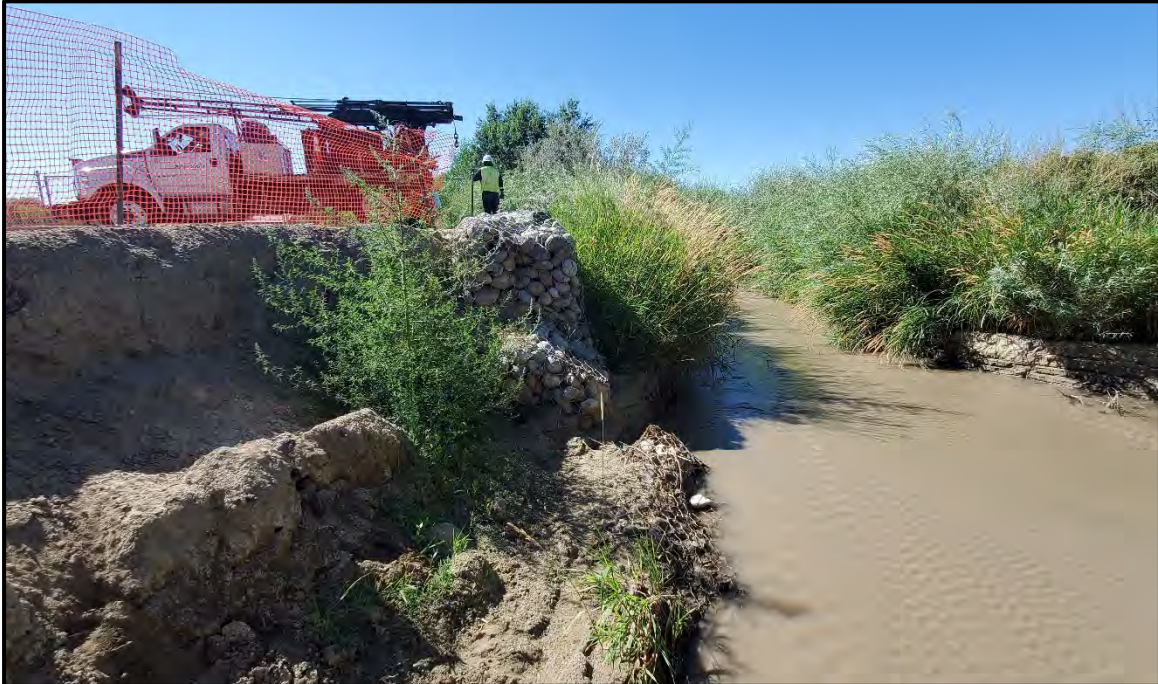
**Damaged Gabion Wall near Boring B-3
View Towards the South**

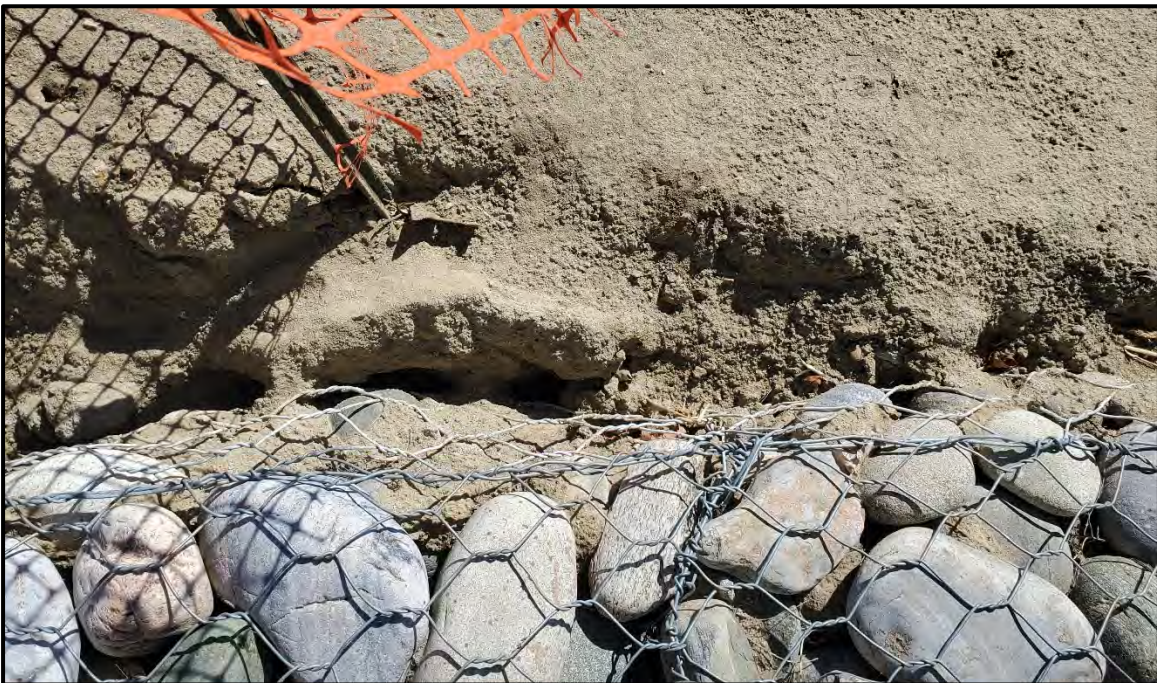
**Piping behind Damaged Gabion Wall near Boring B-3
View Towards the East**

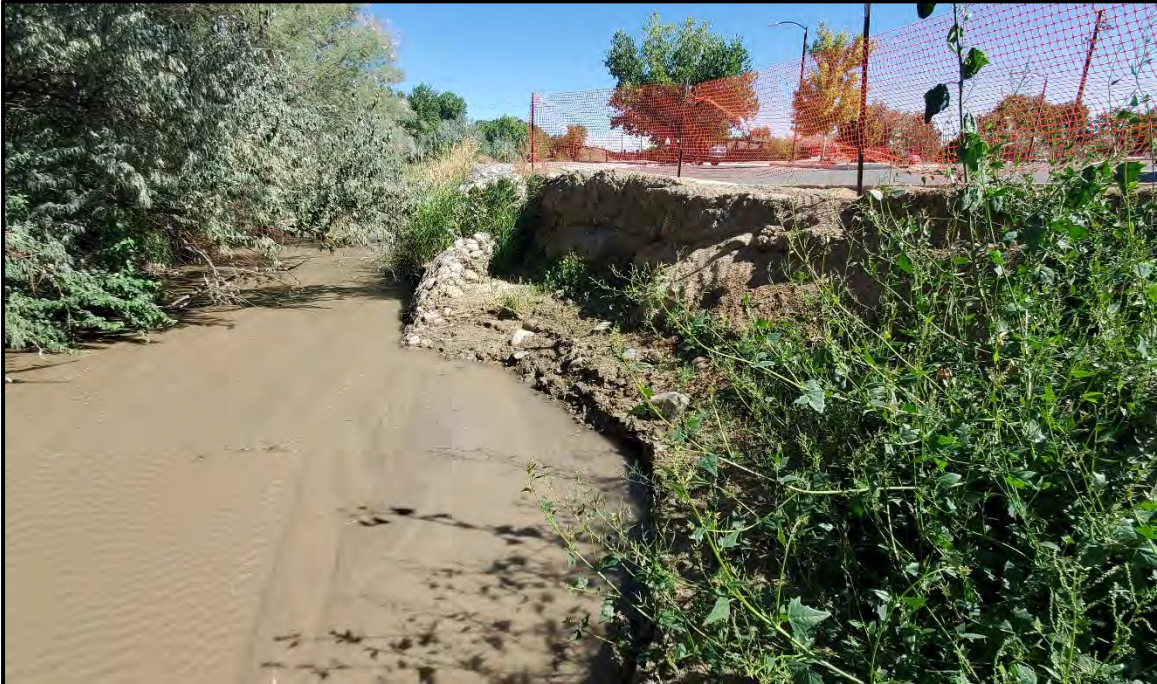
**Damaged Gabion Wall near Boring B-3
View Towards the North**

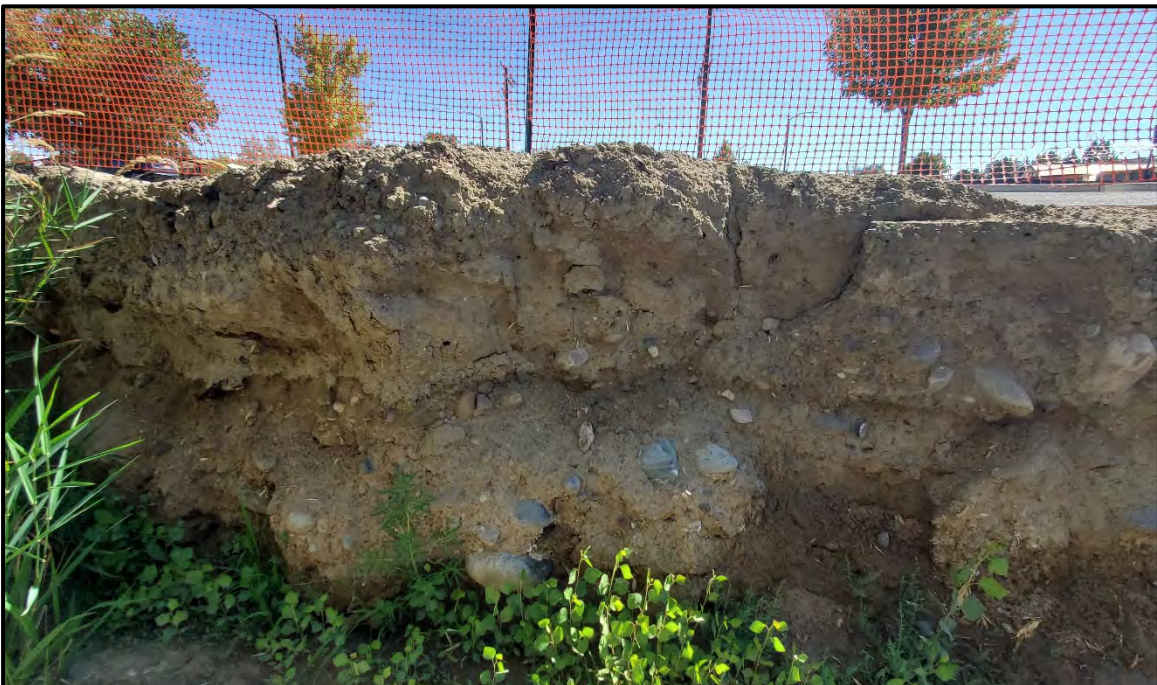
**Fill Behind Gabion Wall near Boring B-3
View Towards the East**
