**City of Aztec  
Parks and Recreation Enhancement Plan (PREP)  
2024**

## SECTION 1. PURPOSE AND SCOPE

## SECTION 2. PARKS AND FACILITIES ASSESSMENT

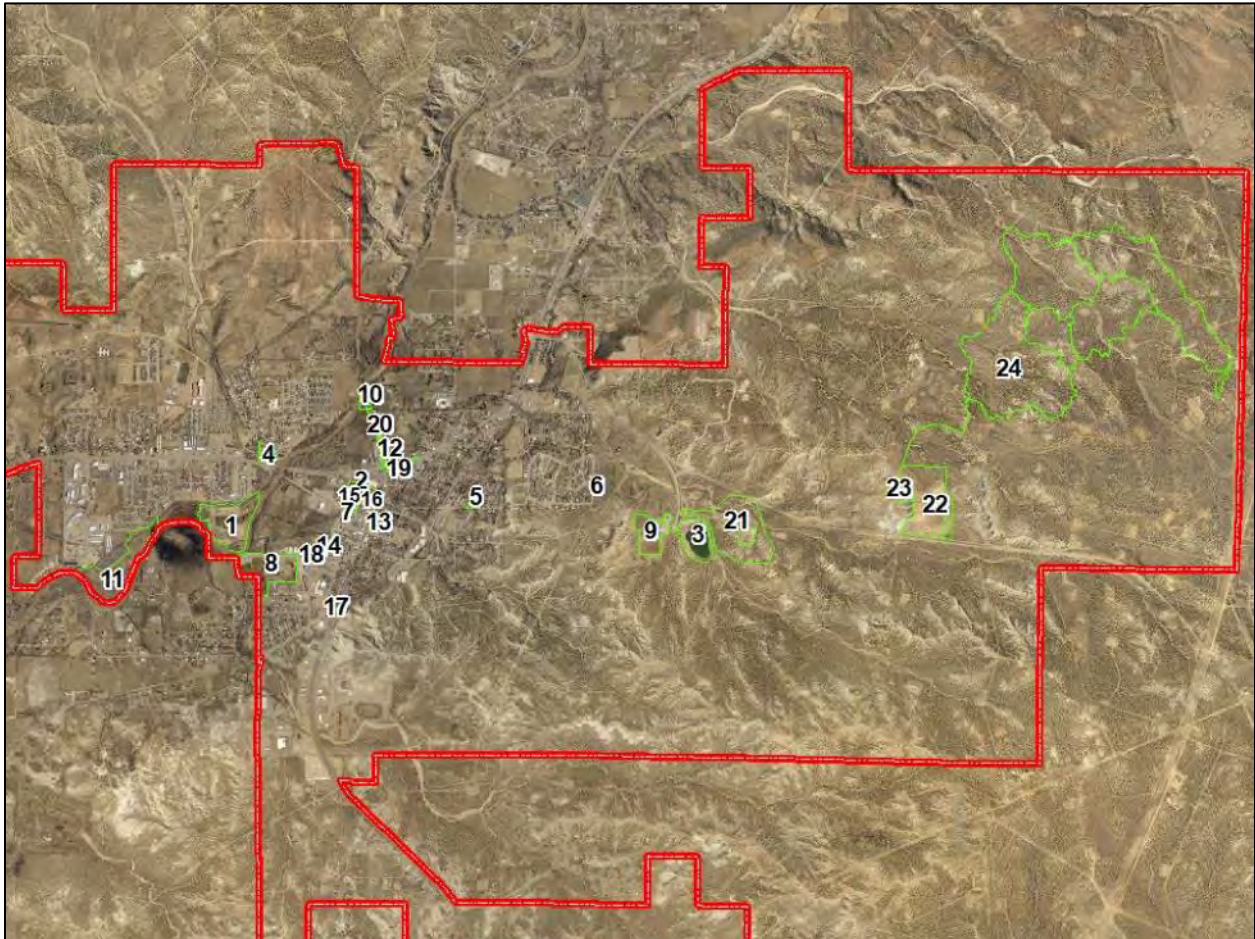
**Figure 2.1. Location of City Parks and Special Use Areas.**

The City of Aztec has 26 park and special use areas for an approximate total of 263.6 acres (Figure 2.1, Table 2.1). These parks and special use areas range in size from 0.1 acres to 52.0 acres.

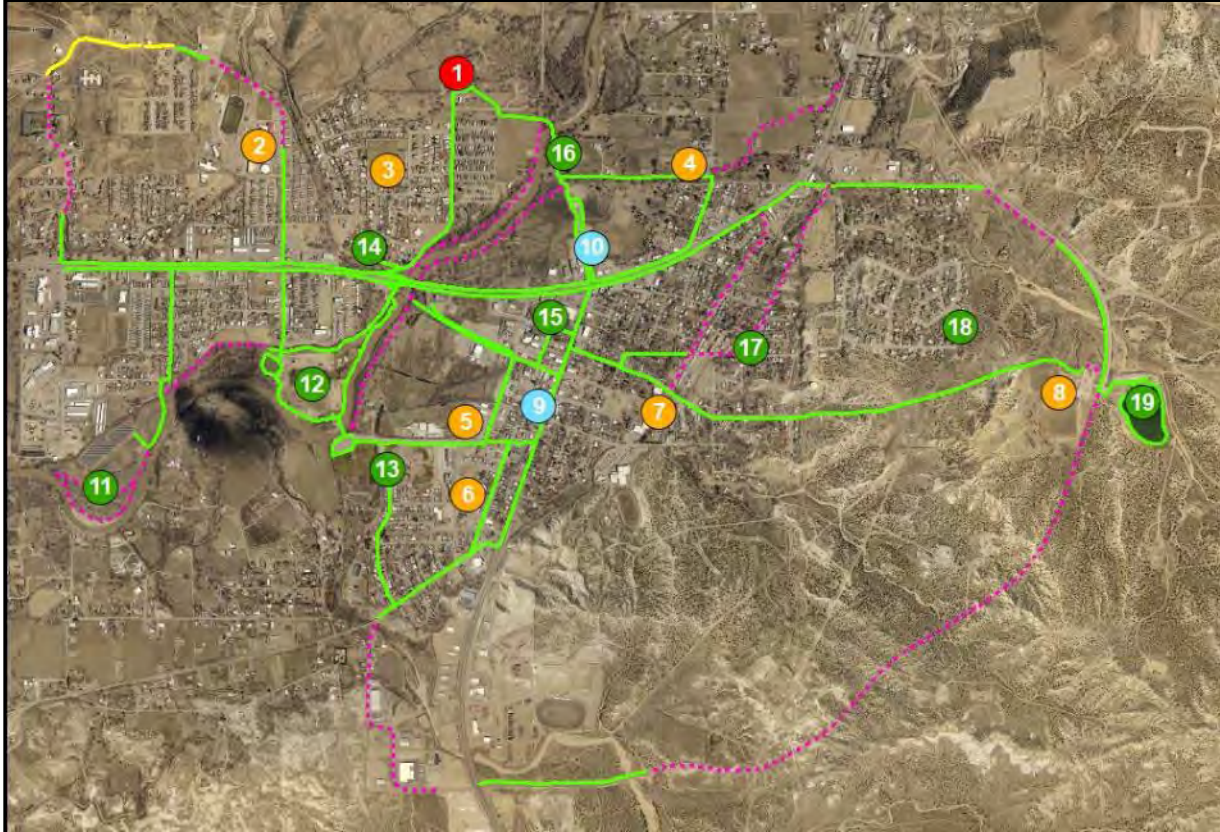
**Figure 3.1. Connecting the Resources** (originally taken from the ARTS Plan 2010, updated to reflect changes up to 2024).

Figure 3.1 provides a map showing the various resources and delineates the existing pedestrian way (highlighted in light green), proposed pedestrian way (dashed in pink), and under construction (highlighted in yellow) at the time of this plan development.

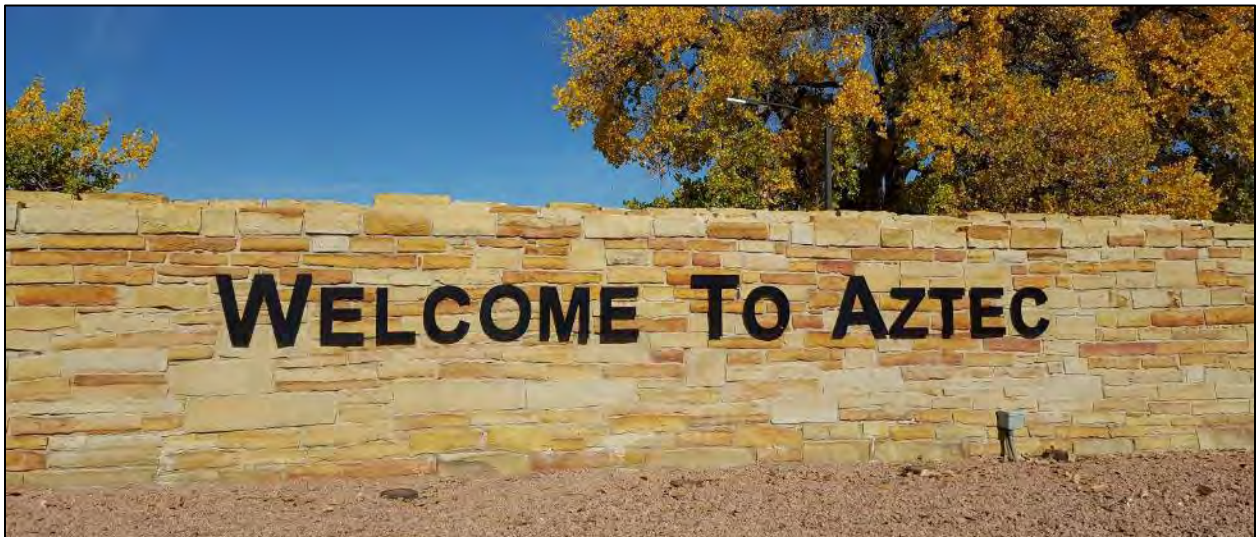
**Figure 4.1. South Main Avenue Gateway with Welcome Monument Sign.**

This gateway included the addition of new sidewalks to extend pedestrian access from historic downtown Aztec to the post office. The corner has a masonry wall constructed under approved NMDOT barrier walls specifications with stone masonry veneers to assimilate the Aztec Ruins National Monument pueblo structures. The slopes were cobbled and a parking lot was developed for local businesses and the public. A picnic table beneath a large cottonwood tree was installed to allow business employees or visitors to have a rest area. The work on this gateway was completed in 2013. Because of the presence of a parking lot and picnic area, this facility was assessed as a Special Use Area and has been evaluated under Section 2.

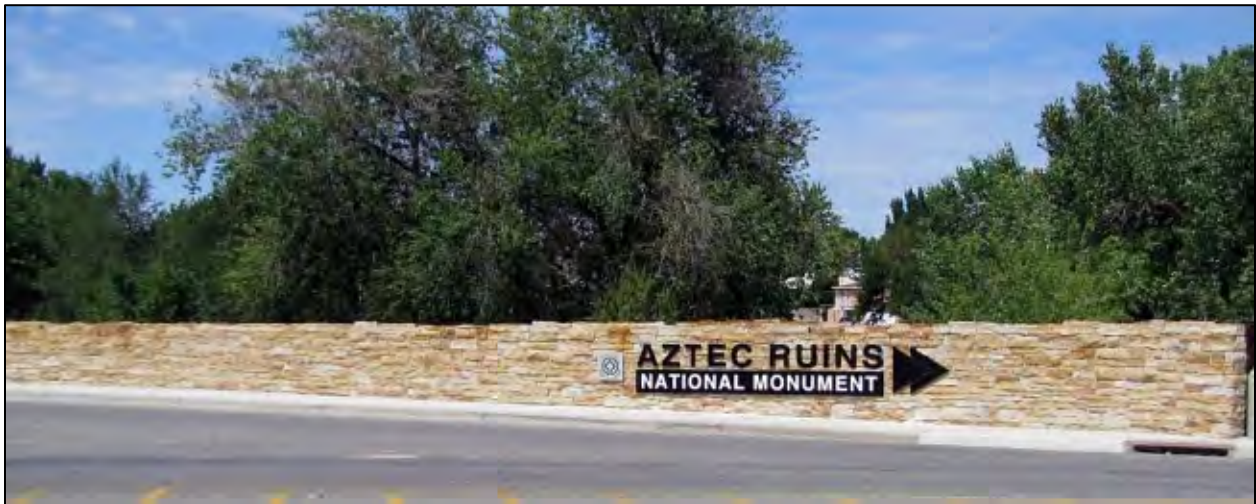
**Figure 4.2. Aztec Ruins Gateway with Wall #1.**

The walls were constructed under approved NMDOT barrier walls specifications with stone masonry veneers to assimilate the Aztec Ruins National Monument pueblo structures. Medians and surrounding areas were xeriscaped with cobble to minimize maintenance efforts and imitate the Animas River corridor.

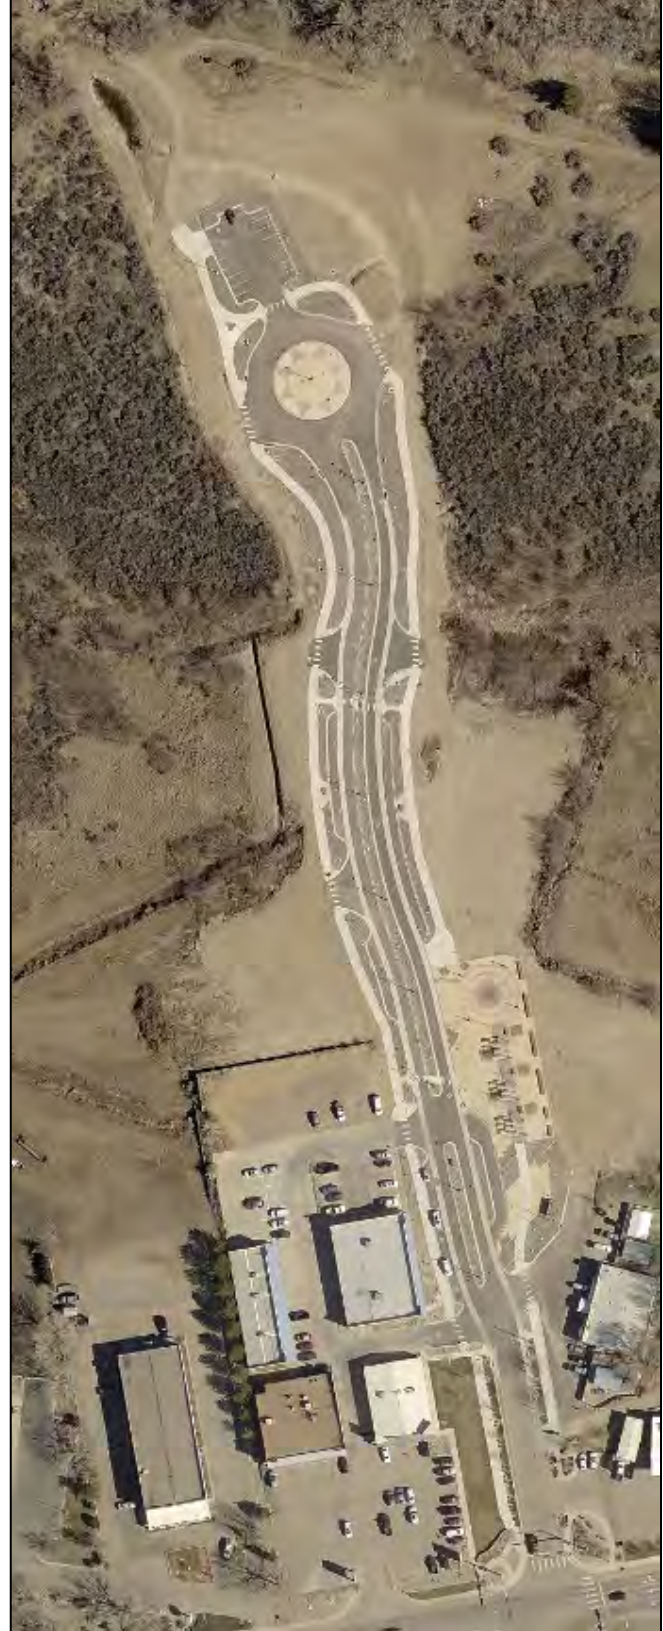
**Figure 4.4. North Main Extension.**

The extension of North Main was completed in 2022. The approach to this corridor was to make it pedestrian friendly and slow and control road traffic. As such, it was designed with wide sidewalks with landscaping between the sidewalks and road edge.

Given the southwest desert environment, the City avoided using grass for landscaping and focused on drought tolerant vegetation and trees. This area, due to its size and complexity requires maintenance much similar to a small neighborhood park and as such was assessed and included in Section 2 assessments.

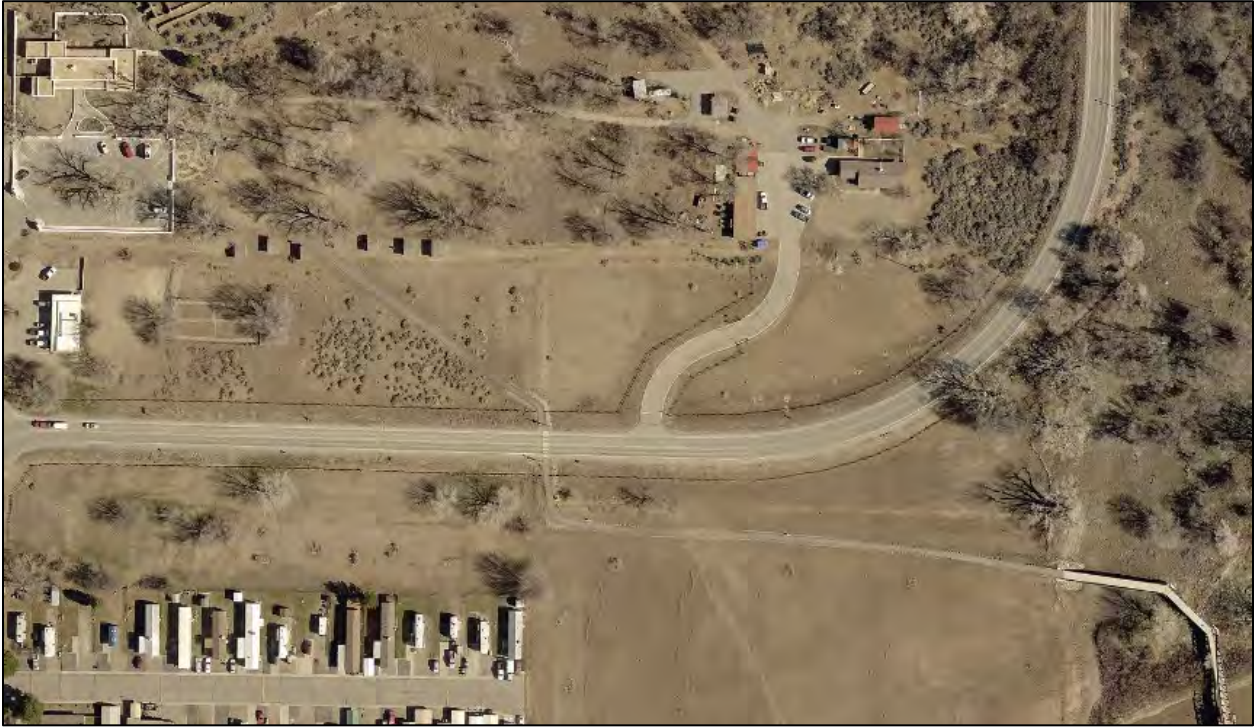
**Figure 7.1. Aztec Ruins National Monument Trail.**

This trail segment is 1,216 ft long and constructed of crusher fine cemented with a polymer (polypavement) and was completed in 2014. All maintenance on this trail is done by the Aztec Ruins National Monument.

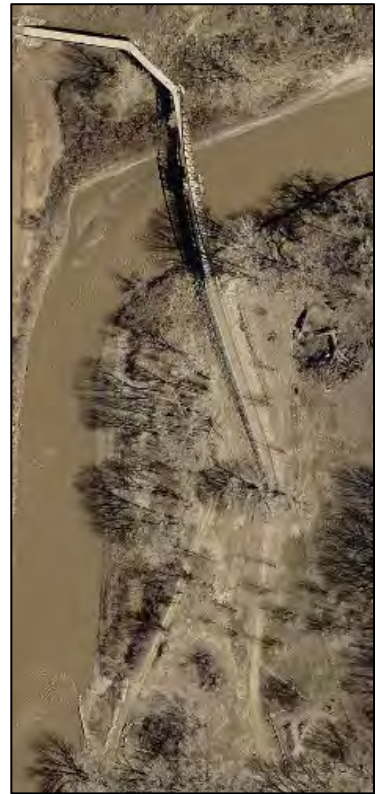
**Figure 7.2. Rio de Animas Park Trail**

This trail segment is 582 ft long and constructed of crusher fine cemented with a polymer (polypavement) and was completed in 2014. All maintenance on this trail is done by the City. Subsequently the surface bonding has decayed and become brittle. It now functions more like a crusher fine trail and not a cemented surface.

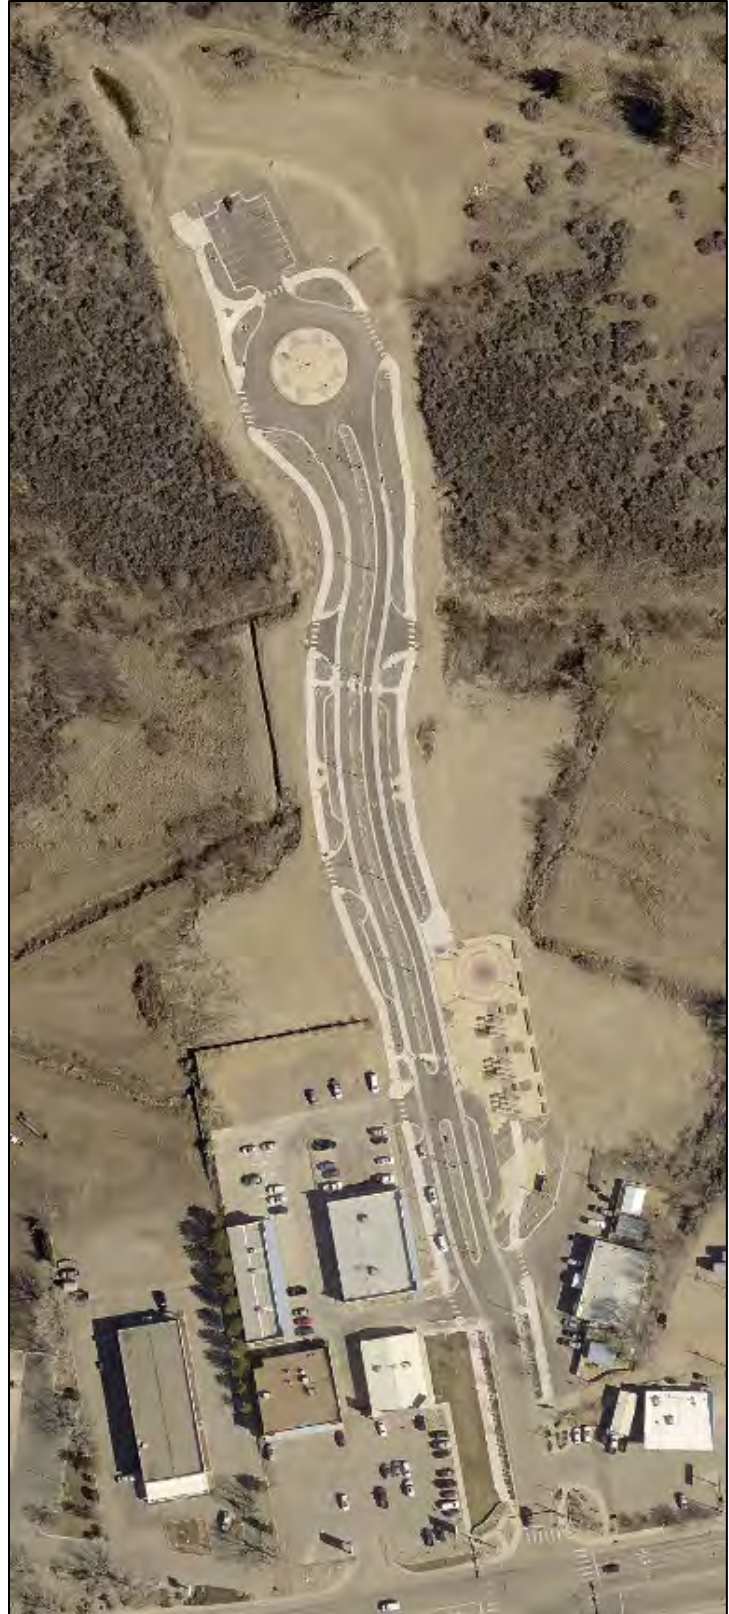
**Figure 7.3. North Main Extension Trail.**

- 3. North Main Extension Trail**  
This trail segment consists of 10ft wide sidewalks along the east and west sides of the North Main Extension (1,950 ft). The sidewalks terminate at the remote parking area and then converts over to a 330 ft gravel trail. At the southeast terminus is the Armijo Plaza.
