**City of Aztec
Parks and Recreation Enhancement Plan
2016**

SECTION 1. PURPOSE AND SCOPE

SECTION 2. PARKS AND FACILITIES ASSESSMENT

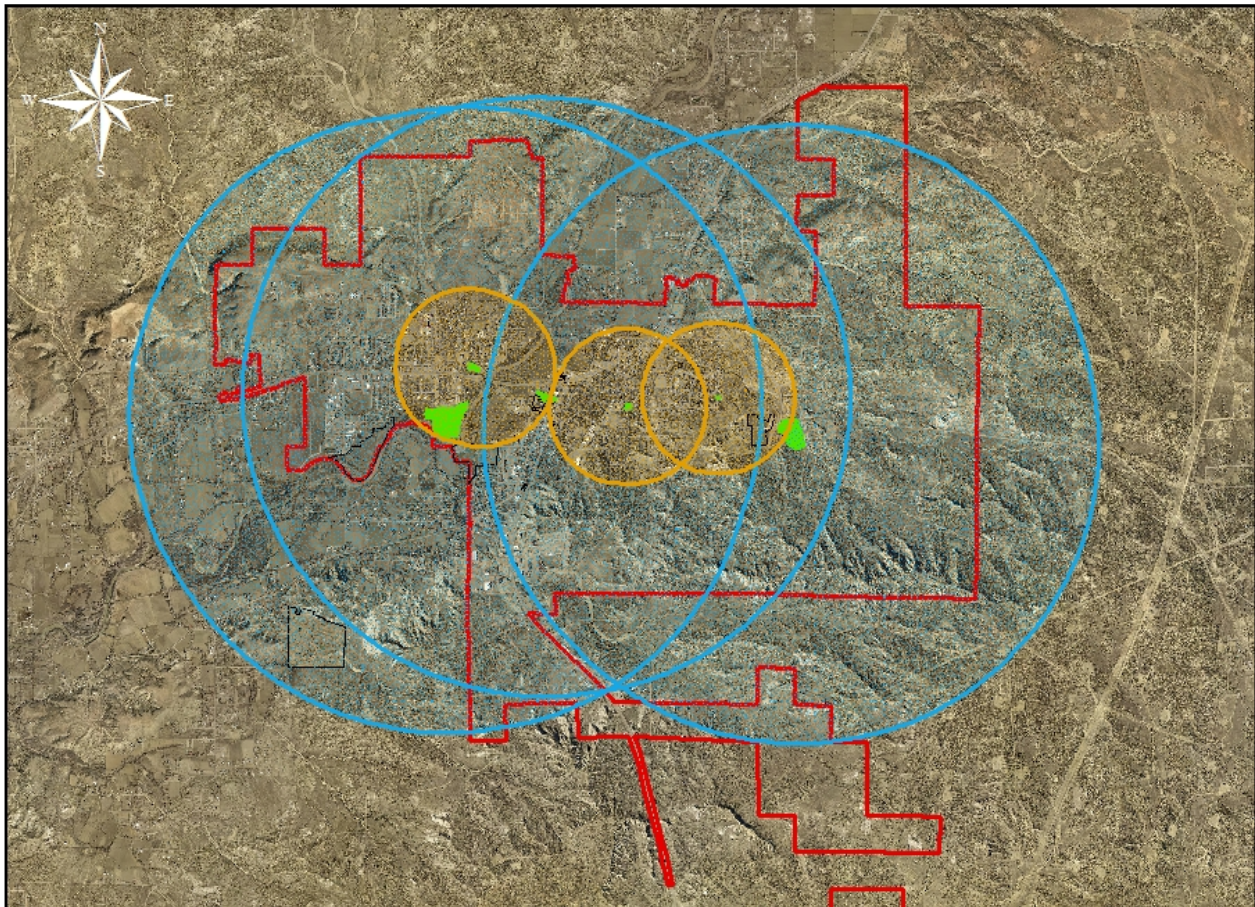
Figure 2.2. Extent of Service Areas for Neighborhood (0.5 miles in orange) and Community Parks (2 miles in blue).

Figure 2.2 shows the extent of the service area for neighborhood and community parks. As shown, all of the urban residential areas within the city are serviced by at least one community park with several urban residential areas being serviced by multiple parks based upon the service area standard established by NRPA. Only rural residential areas located far east, south, and west along city limits do not fall within the recommended NRPA service areas.

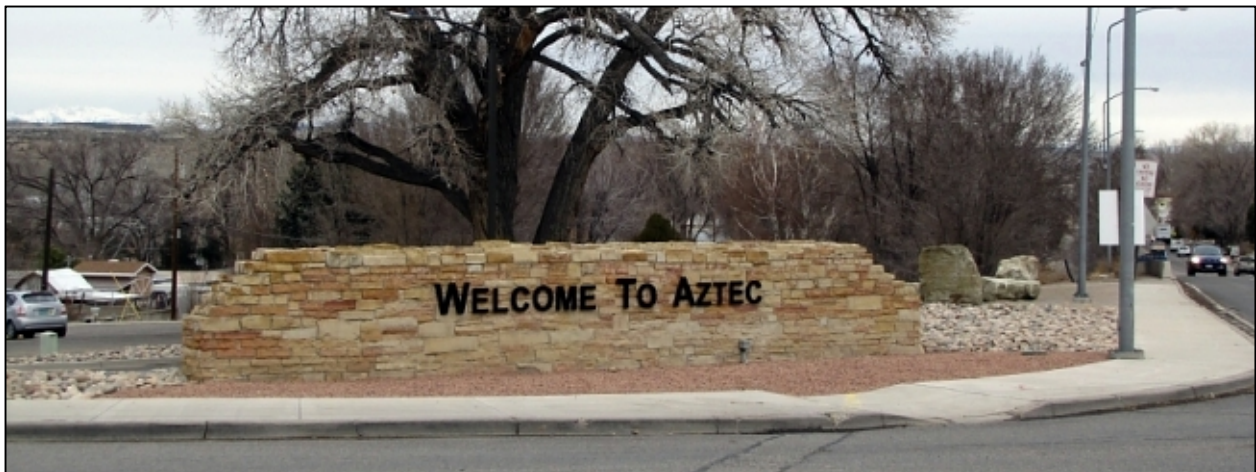
Figure 4.1. South Main Avenue Gateway with Welcome Monument Sign.

This gateway included the addition of new sidewalks to extend pedestrian access from historic downtown Aztec to the post office. The corner has a masonry wall constructed under approved NMDOT barrier walls specifications with stone masonry veneers to assimilate the Aztec Ruins National Monument pueblo structures. The slopes were cobbled and a parking lot was developed for local businesses and the public. A picnic table beneath a large cottonwood tree was installed to allow business employees or visitors to have a rest area. The work on this gateway was completed in 2013. Because of the presence of a parking lot and picnic area, this facility was assessed as a Special Use Area and has been evaluated under Section 2.

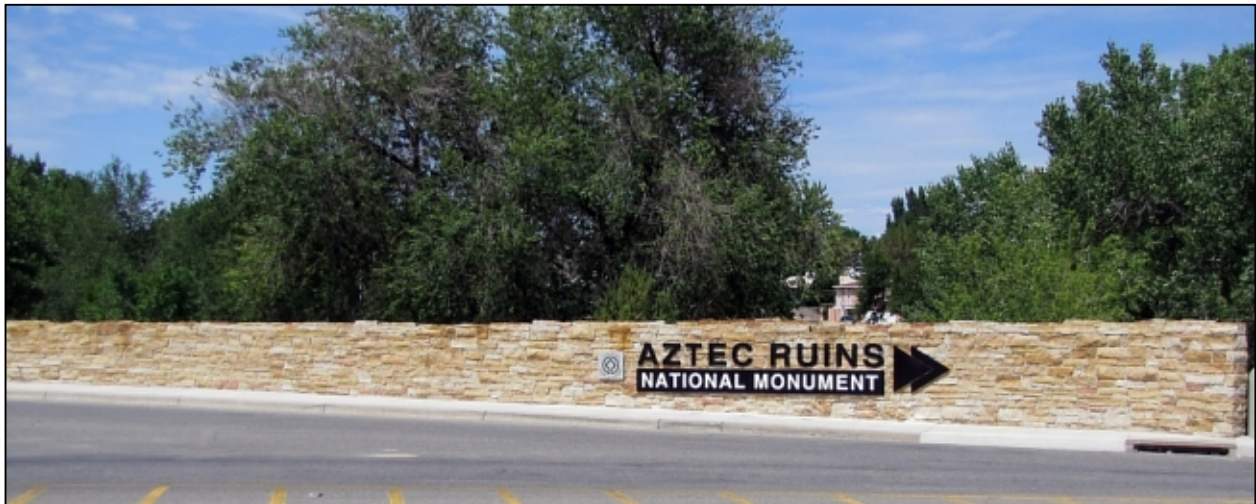
Figure 4.2. Aztec Ruins Gateway with Wall #1.

The walls were constructed under approved NMDOT barrier walls specifications with stone masonry veneers to assimilate the Aztec Ruins National Monument pueblo structures. Medians and surrounding areas were xeriscaped with cobble to minimize maintenance efforts and imitate the Animas River corridor.

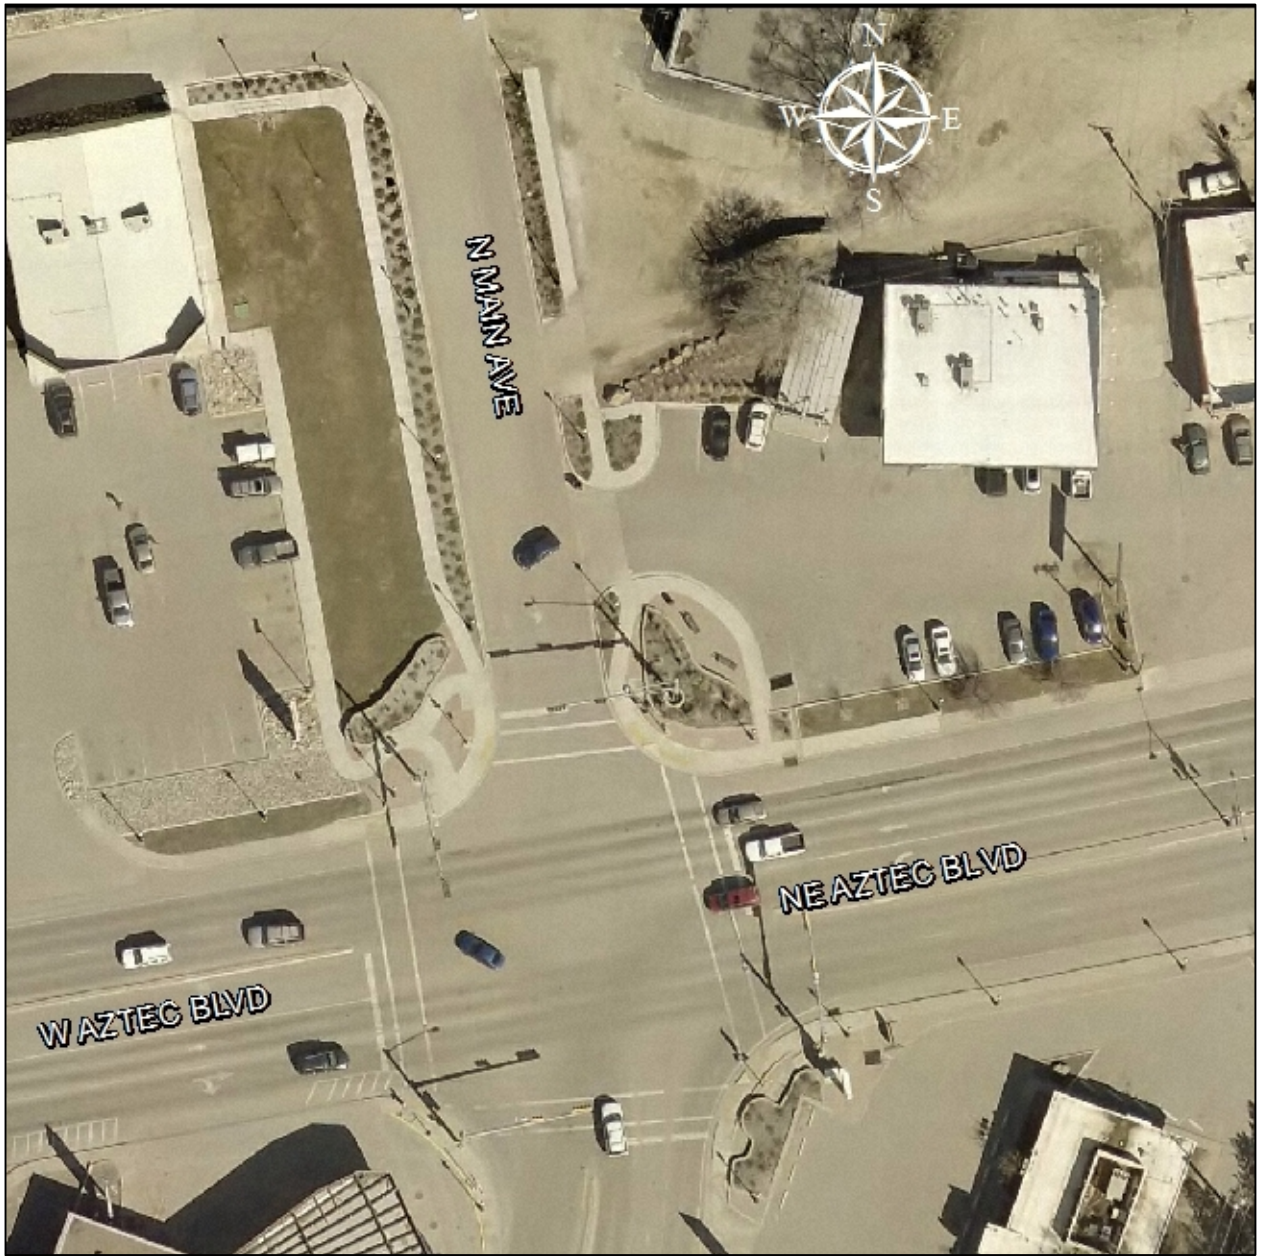
Figure 4.4. Aztec – Main Intersection.

The project has included the construction of new sidewalks, raised planter boxes, brick inlay work, installation of benches, the development of a green turf and tree areas, planting of various drought resistant plants, added street lighting, and some road median work. Because of pedestrian amenities, this area was assessed under Section 2 as a Special Use Area.

It is from this intersection that the trail system will be extended to the north to connect downtown Aztec with the Aztec Ruins National Monument. Commonly known as the North Main Corridor, the conceptual work for this trail system was provided earlier in Section 3. Construction was begun in 2015 and will continue in phases over the next 3 to 4 years.
