MEMORANDUM

DATE: October 14, 2019

SUBJECT: City of Aztec Reservoir No. 1 Rehabilitation Project

The City of Aztec has contracted Bohannon Huston, Inc. (BHI) to evaluate the existing condition of Reservoir 1 in Aztec, NM, as well as assess the rehabilitation potential of the reservoir and make a recommendation on whether the reservoir should be rehabilitated or if it is more advantageous to construct a new reservoir.

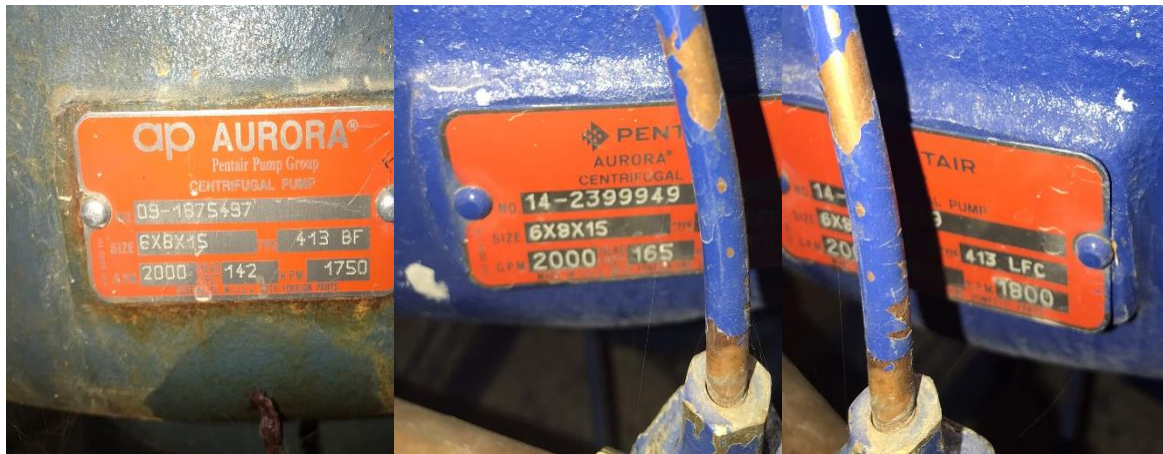
Figure 25 – Pump Nameplates

Under current operations, water is pumped to Reservoir 2 from the Animas Ditch or the Animas River and is then pumped from Reservoir 2 to Reservoir 3 via the Navajo Pump Station. The pump station has two pumps rated at 2,000 GPM in a 1+1 configuration. A picture of the nameplates is shown below.

Pressure and flow readings taken during the site visit on February 2, 2019 downstream of the pump were 1,800 GPM at a pressure of 88 psi with one pump operational. This operating point is slightly lower than the 2,000 gpm that the pump is rated for, see Figure 28 for the existing pump curve. Additional readings were taken on a subsequent site visit on July 30, 2019, with similar results. The test points are shown on System Curve Figure 30. Figure 26 contains a simplified schematic of the current operations and the proposed operations with the rehabilitation of Reservoir 1. From Reservoir 3, the water gravity feeds to the WTP prior to distribution. The hydraulic profile of the current system is displayed in Figure 27.

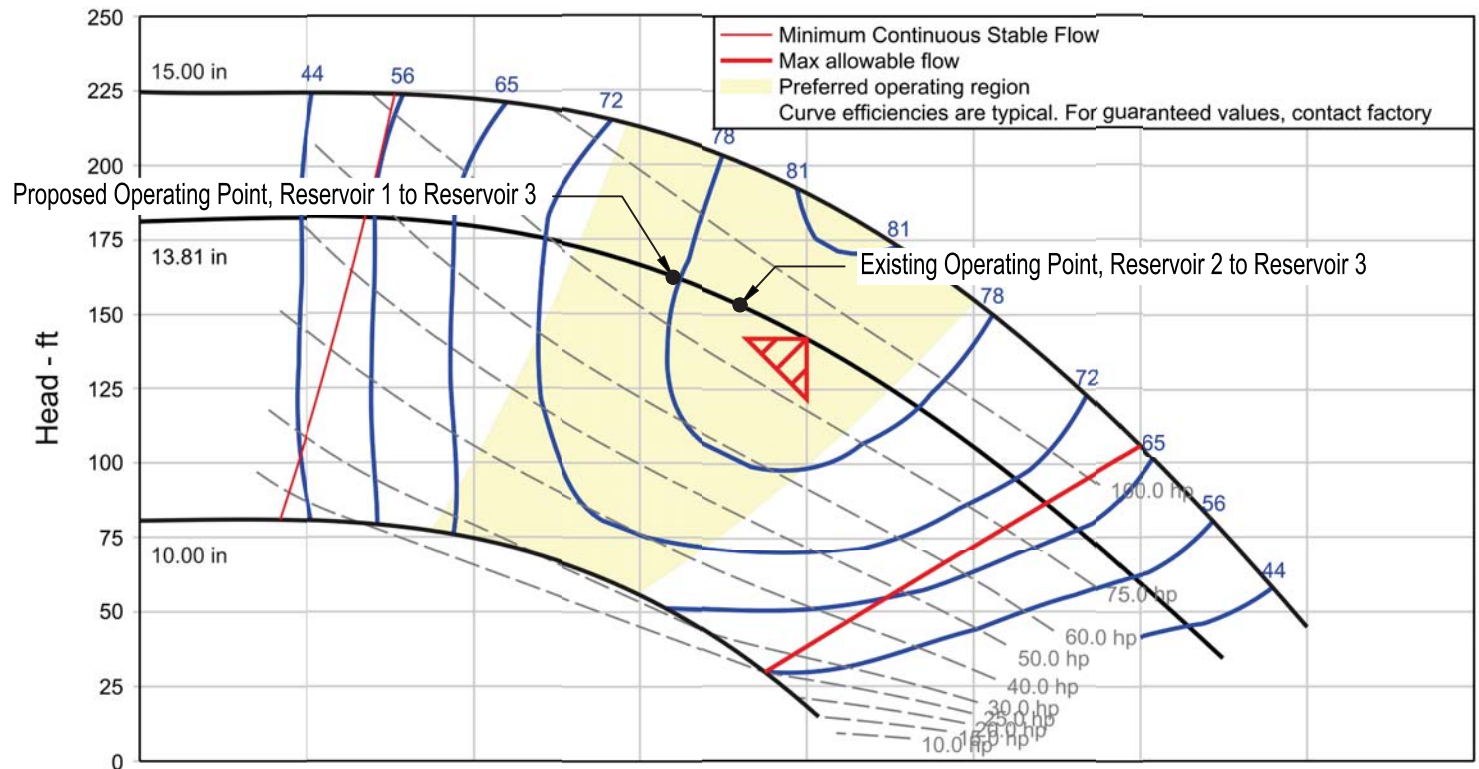
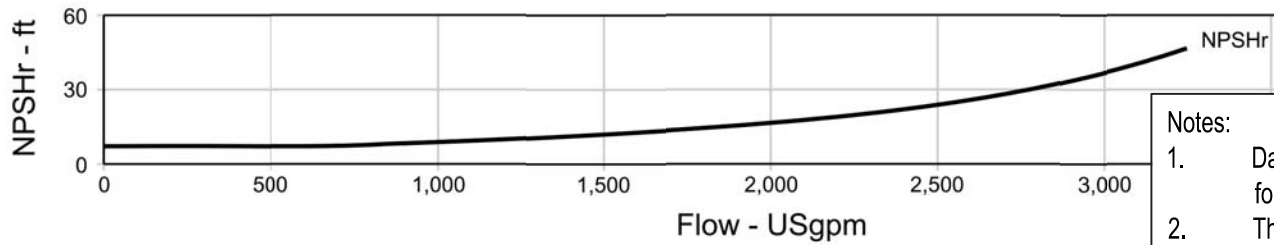
Figure 28
 Pump Curve
 Existing Pumps

The existing pump in use is a Pentair centrifugal vertical split case pump rated for 2,000 gpm, 142 feet of head, and 1,750 rpm. Using estimated WSEs of 5,825 ft and 5,760 ft, respectively for Reservoir 3 and Reservoir 2, the Static Head was determined to be 75 ft, making the Total Dynamic Head (TDH) approximately 154 ft. The observed performance point of 1,800 gpm at 88 psi from the February 2019 site visit was used to calibrate the system curve by refining the friction coefficient for the pipe. The friction value (C factor) was determined to be 105 and was taken to be the representative friction value for the system and is used in all the system curves in this report. The reservoir water surface elevations for the suction side reservoirs are estimated at half full in order to account for more conservative low water operating conditions.

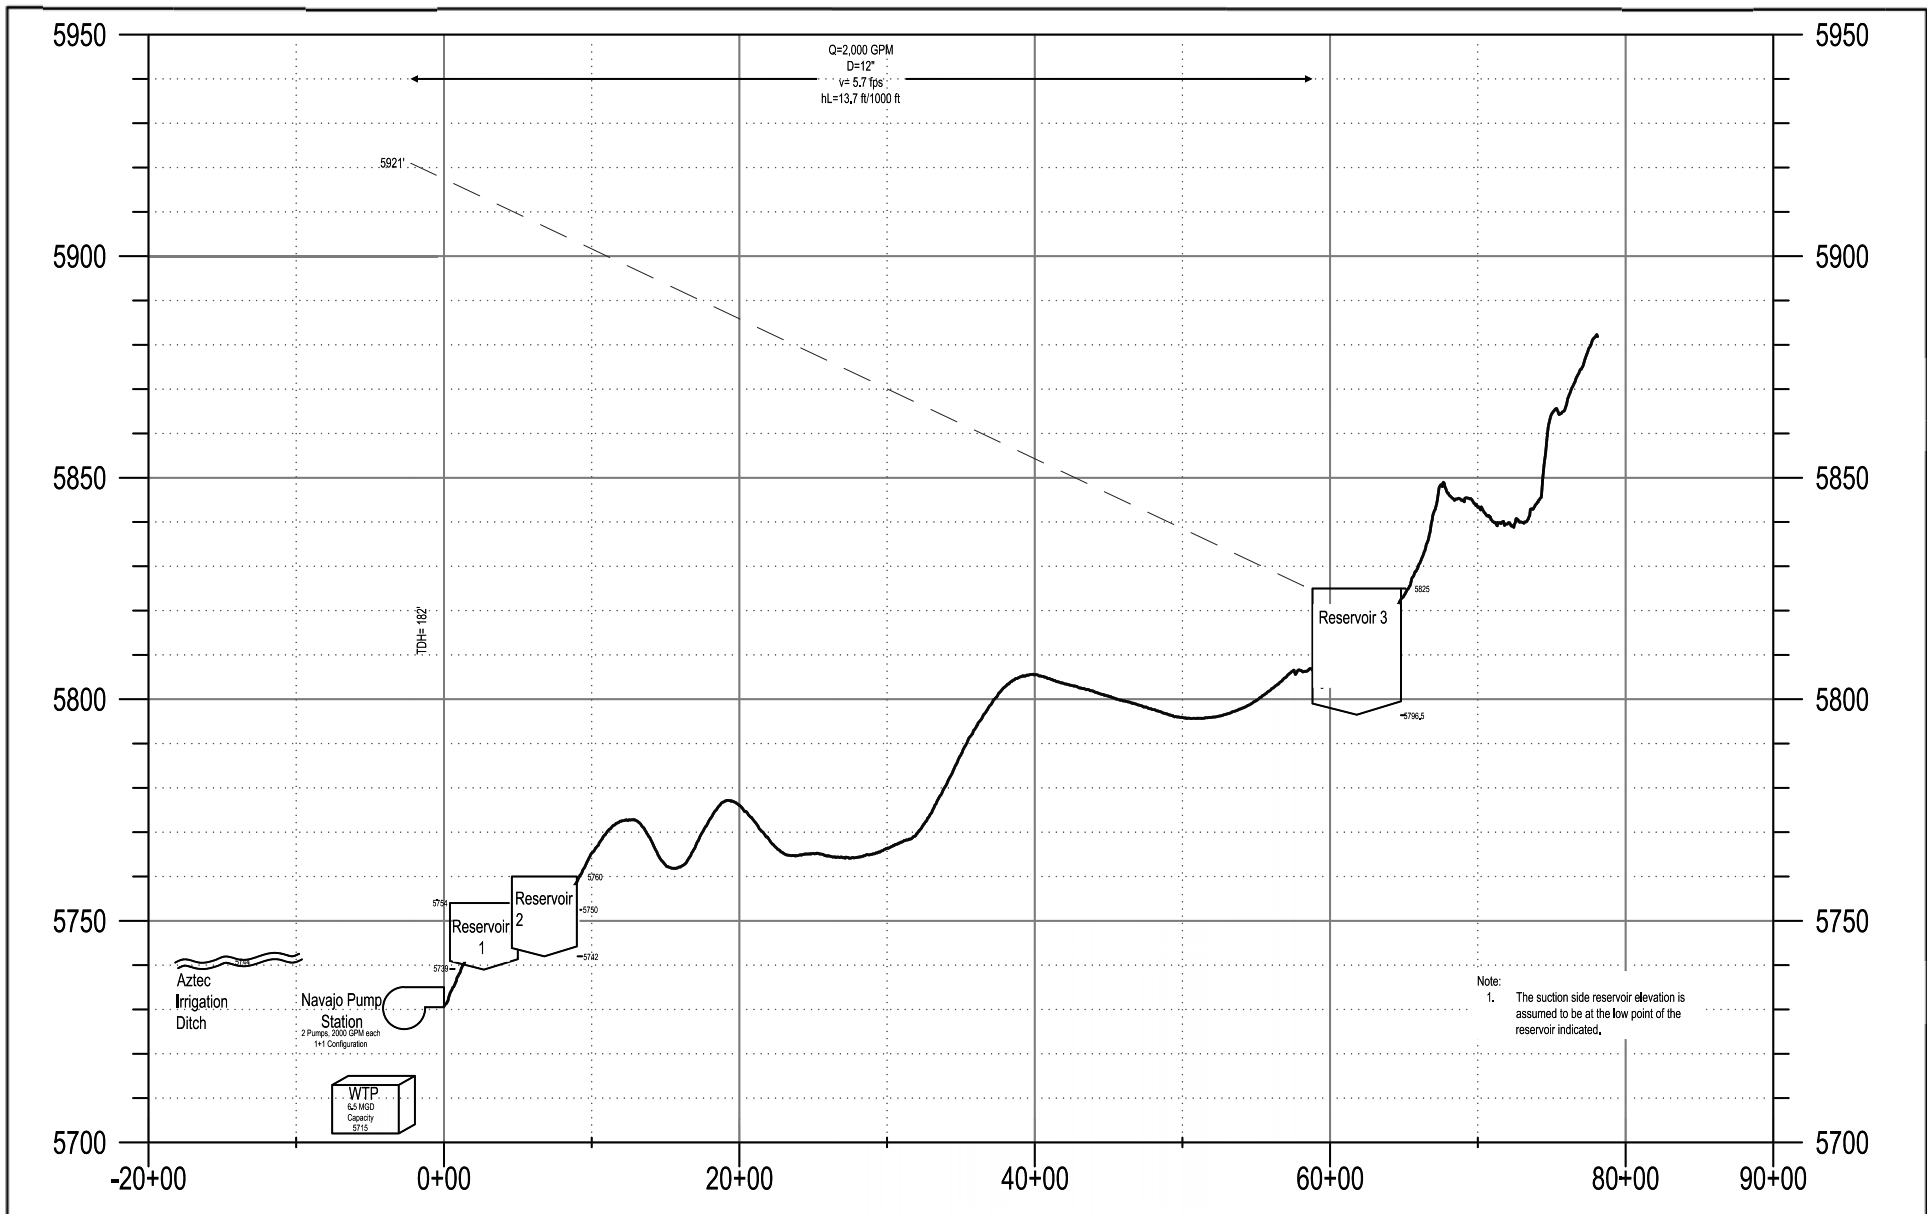
Figure 29
 Hydraulic Profile
 Reservoir 1 Rehabilitation

The proposed rehabilitation of Reservoir 1 for reinstatement into the system would reverse the sequence that water is fed into the reservoirs and would impact the hydraulic performance of the system by reducing the available suction pressure on the inlet side of the pumps. Reservoir 1 is the only reservoir in the system that can be gravity fed by the Aztec Irrigation Ditch as it is lower in elevation – 5,744 ft elevation at the Aztec ditch versus 5,739 ft elevation at the bottom of Reservoir 1, see Figure 27 for the hydraulic profile of the existing system and Figure 29 for the hydraulic profile of the system with Reservoir 1 reinstated. Restoring Reservoir 1 back to service would mean a decrease in necessary pumping of source water with the current pumps. Water from Reservoir 1 is pumped by the Navajo Pump Station to Reservoir 3. Based on the facility elevations, the projected flowrate for this operation is only 1,600 GPM with the existing pump. The water then flows by gravity to Reservoir 2 and then finally to the WTP. Pump performance is impacted by the change in the elevation difference between the suction side reservoir and the downstream reservoir. The suction side reservoir would switch from Reservoir 2 to Reservoir 1 following a rehab of Reservoir 1 which has a negative impact on the system performance.

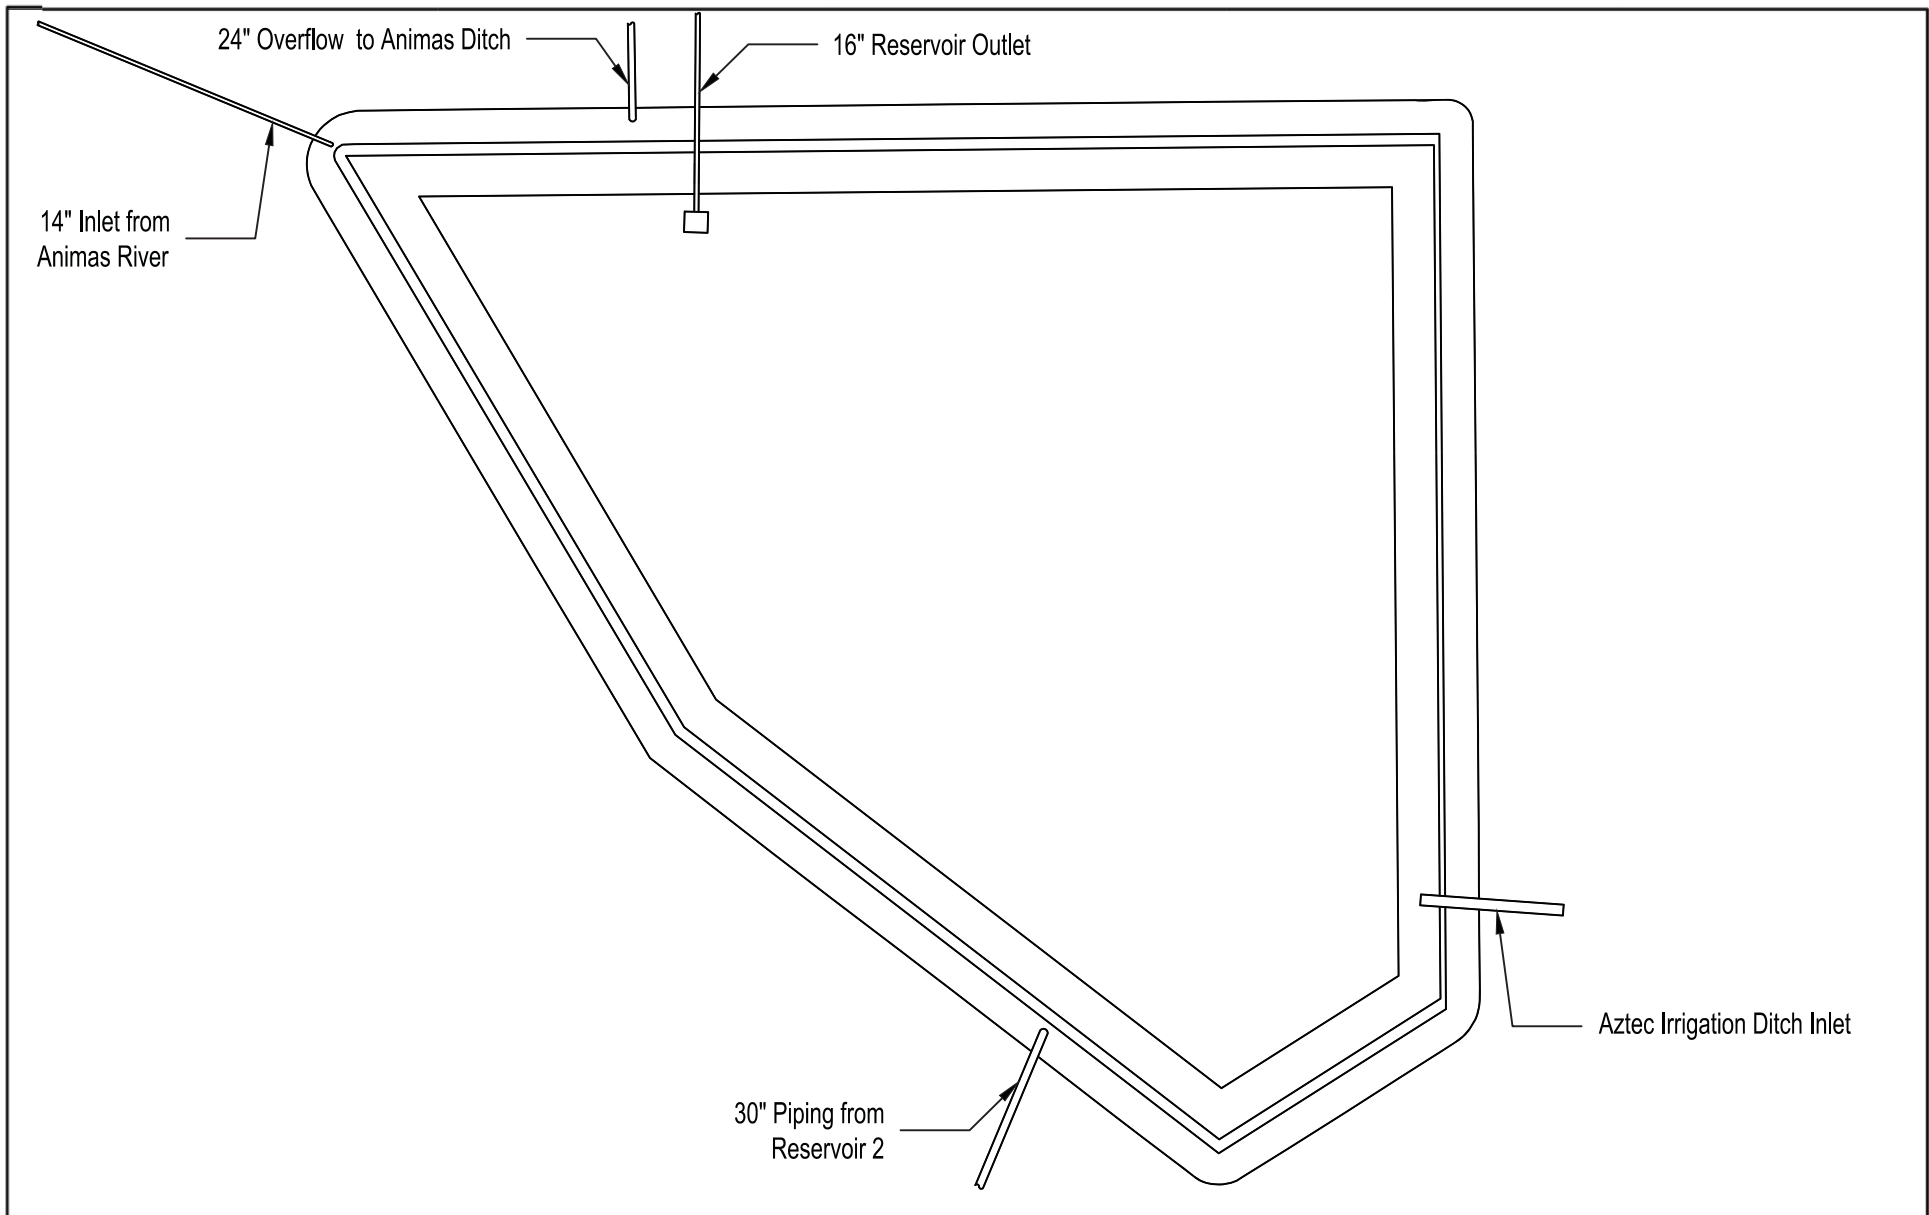
Figure 33
 Reservoir 1
 Inlet and Outlet Locations

30-inch Piping from Reservoir 2 - The piping from Reservoir 2 to Reservoir 1 is in Zone 4 of the reservoir which contains a significant amount of damage to the structural integrity of the concrete due to this outfall. The approximately 350 LF of piping should be replaced as part of the project.

24-inch Overflow to Animas Ditch - The overflow line to the Aztec ditch is silted in and needs replacement; this includes approximately 450 LF of 24-inch pipe.

16-inch Drainage Line and Valve - The tower is in poor condition and needs replacement, the piping and valve to the pump station should also be replaced as part of this effort as the piping appears corroded and the valve is leaking.

Outlet Structure Tower- During the site evaluation, it was noted that there are underlying problems beneath the most recent layer of concrete. There is concern that the exposure to water and freeze-thaw over time has compromised the structural integrity of the tower. Regardless of which option is chosen, we recommend that a new outlet structure be built at the location of the existing structure. Although the steel bridge used to access the structure was found to be in decent condition and could be reused after rehab and recoating of the steel members, it is also recommended that the catwalk be replaced with the tower.

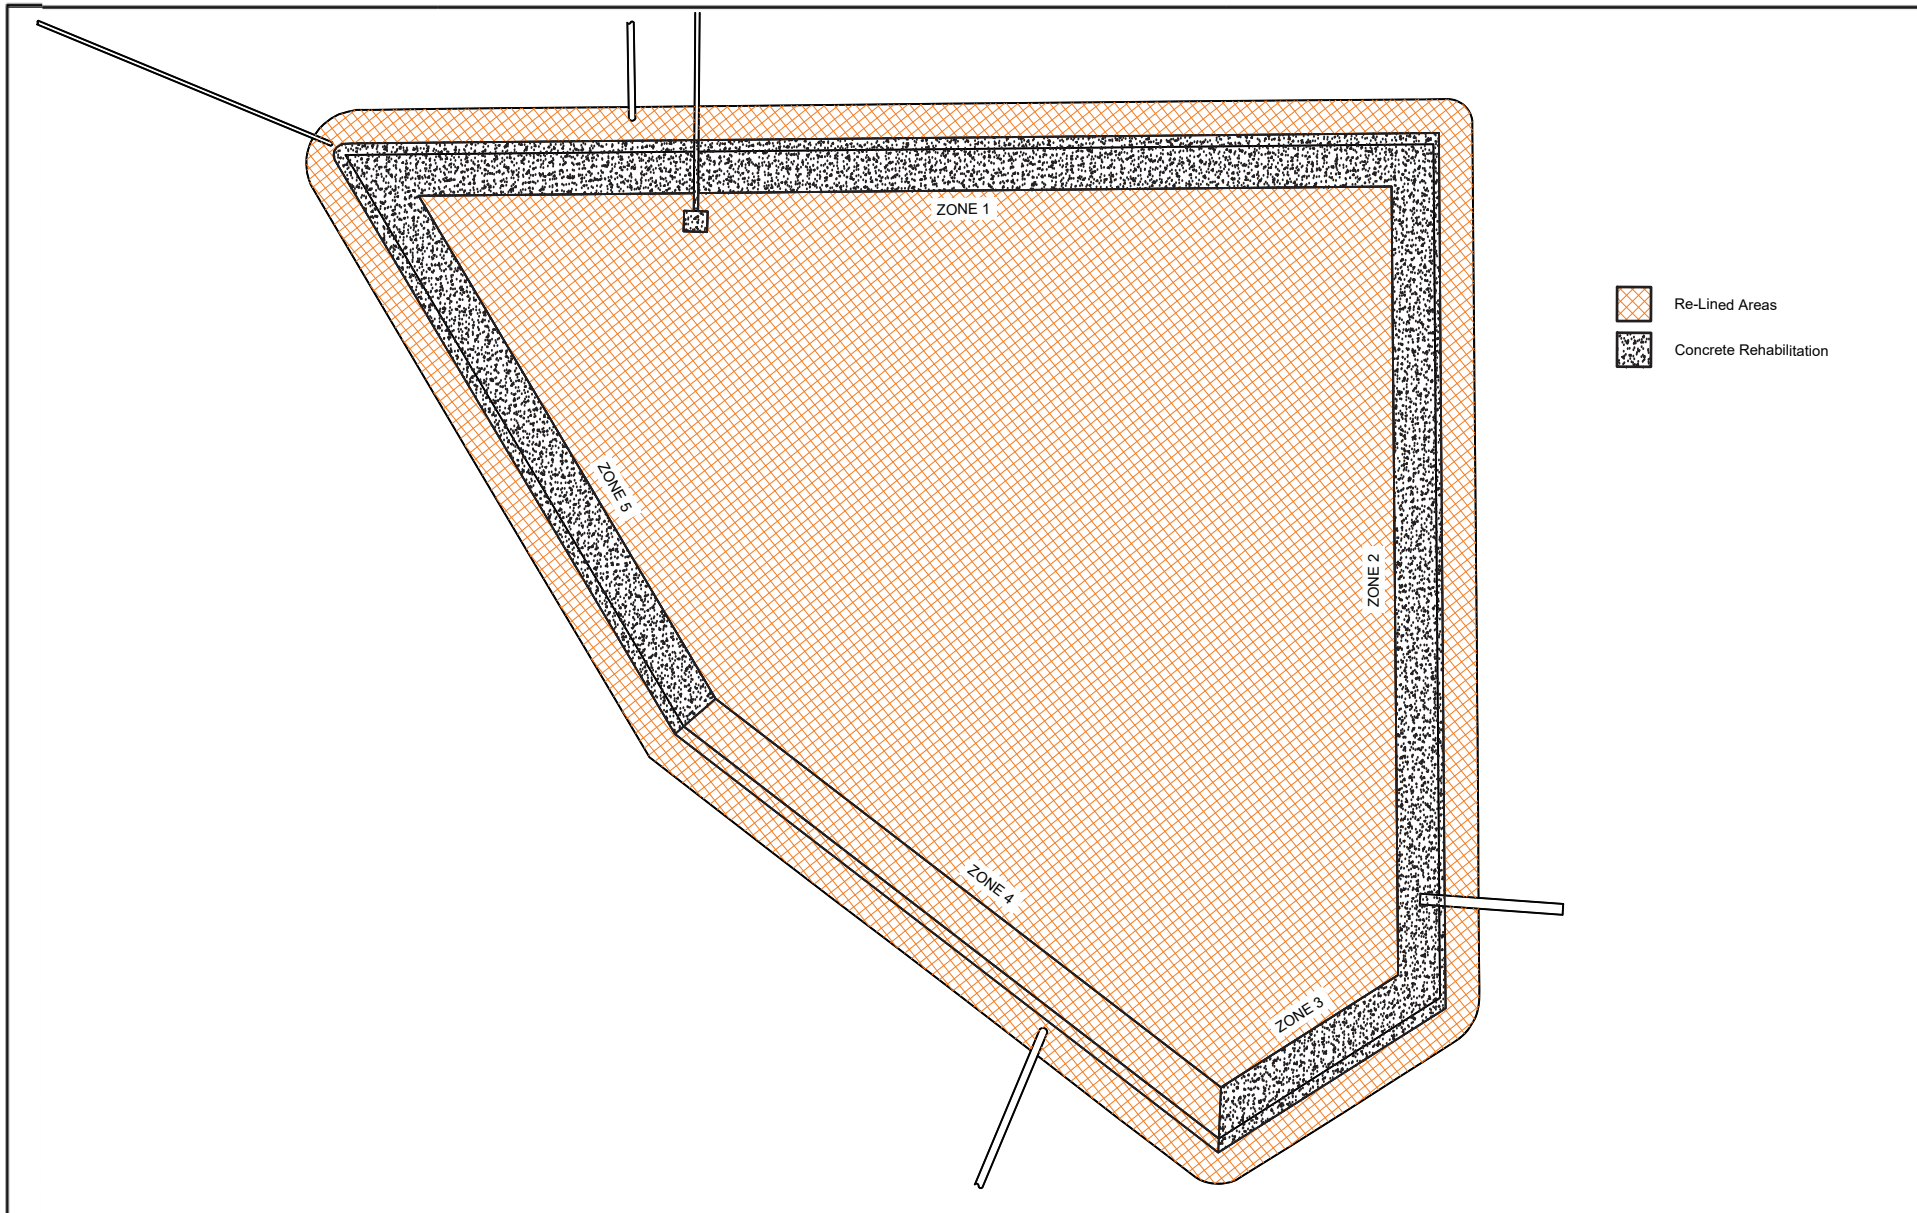
Figure 34
 Reservoir 1
 Option 2 Re-Lined Areas

Another method evaluated to restore the integrity of the reservoir, is adding an impermeable synthetic liner in addition to repairing some of the existing panels. Figure 34 displays the areas where the liner would be installed and the areas that would consist solely of concrete rehabilitation. From our site visit evaluation, it was determined that in order to maintain the integrity of the reservoir, all concrete panels in the upper half of the reservoir would need to be cleared of faulty material and replaced by a layer of impermeable liner. To achieve a successful installation of the liner in the upper half, the shotcrete panels would need to be ground down to a flattened surface in order to avoid ripping the liner. The step between the upper and lower sections of the shotcrete panels would need to be completely removed and replaced so that the liner can be properly attached to the upper portion of the reservoir. The liner would also be attached into a newly dug trench of concrete surrounding the top boundary of the reservoir. Based on calculations performed by the team, roughly 116,000 sq. ft of impermeable synthetic liner would be required and 20,382 sq. ft. of concrete would need to be removed.

In regard to the lower portion of the reservoir, panels found to have extensive cracking and/or spalling would require specific maintenance procedures including but not limited to the removal and replacement of all joints and delaminated and spalled concrete. In our evaluation, we determined that Zone 4 (including both top and bottom panels) would need to be completely removed and replaced by the impermeable liner. The team noticed extensive damage to the slopes surrounding the inlet pipe from Reservoir 2 and the placement of the liner would prevent further damage to the earthen slopes. For this option, an estimated 3,541 ft of joint material would be required for the lower portion.

This alternative will use a 60 mil HDPE liner backed by a 200 mil geonet to provide additional support and cushioning for the liner against the remaining concrete. The area around the inlet/outlet pipes and the ramp would be double lined so that the topmost liner acts as the sacrificial liner in the event of damage, maintaining the watertight integrity of the liner. Although this method of partial concrete rehab/partial liner installation will improve the reservoir integrity, it will not be completely watertight.
